# Access Compliance Report

## Public Rights-of-Way

### (Curb Ramps)

| Intersection ID: N/A | Main Street: SOUTHGROVE_ST | Cross Street: WAVERLY_CENTER_DR | Location: SW |

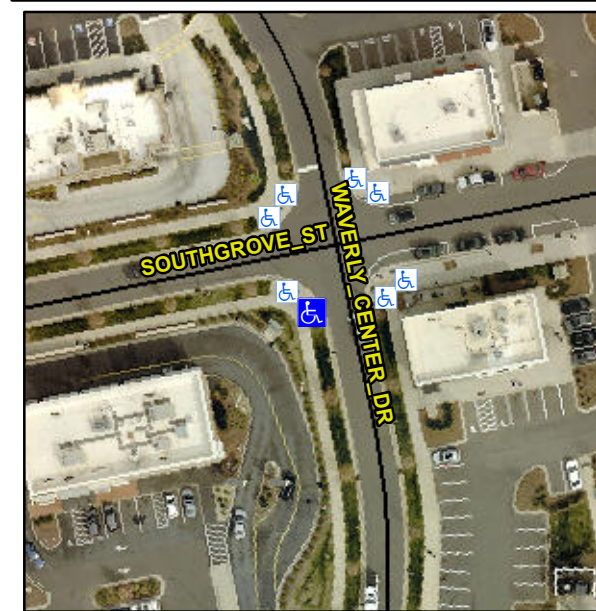
| ADA ID: 3DAED0B6E116 | Ramp Type: Perp | Initial Pass/Fail: Fail | Overall Compliance: No |

**Not Found, R304.5.1, R304.5.3**

| Compliance | Description | Data | Compliance | Description | Data |
|---|---|---|---|---|---|
| N/A | Ramp Length (in) | 96.0 | Yes | Ramp Slope (%) | 6.3 |
| No | Ramp Width (in) | 46.0 | No | Ramp XSlope (%) | 2.3 |

**Remove & Replace Entire Ramp.**

Total Cost: \$ 1850.00
