Access Compliance Report Public Rights-of-Way (Curb Ramps)

Intersection ID: 10041619 Main Street: WHITEHALL COMMONS CENTEROSDIStreet: N/A Location: SE

Overall Compliance: No ADA ID: 3DB2F62AC332 Ramp Type: PerpDiag Initial Pass/Fail: Pass Severity Score: 12.75

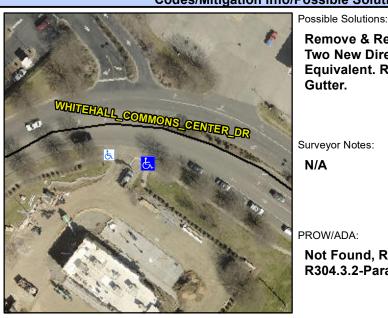
HALL COMMONS CENTER DR Street 1 Name Stop Condition-Street 2 Street 2 Name **ENTRANCE** Stop Condition-Street 1 StopSign Remove & Replace Curb Ramp With Two New Directional Ramps or Equivalent. Remove & Replace Gutter.

Not Found, R304.5.3, R304.2.2-Perp, R304.3.2-Para, R304.2.3, R305
