# Access Compliance Report

## Public Rights-of-Way

### (Curb Ramps)

Intersection ID: 14441	Main Street: E_KINGSTON_AV	Cross Street: SPRINGDALE_AV	Location:	N
ADA ID: 3DB755B3607F	Ramp Type: Directional1	Initial Pass/Fail: Fail	Overall Compliance: No	Severity Score: 25
Codes/Mitigation Info/Possible Solution		Field Measurements/Component Compliance

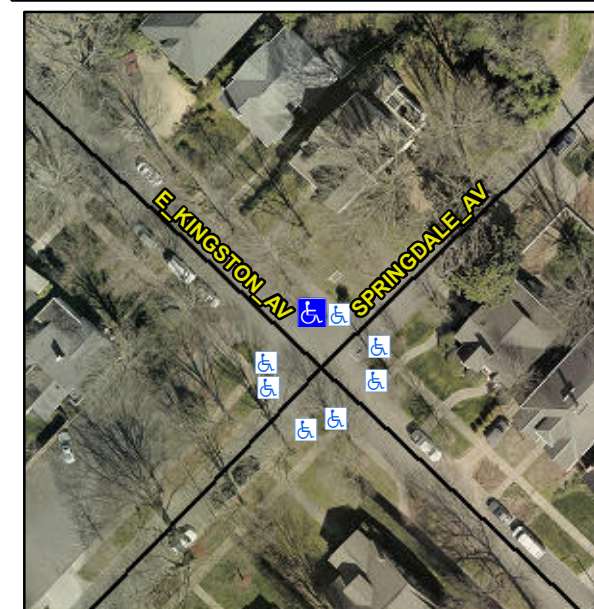
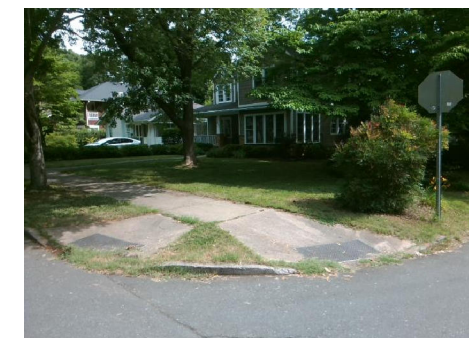
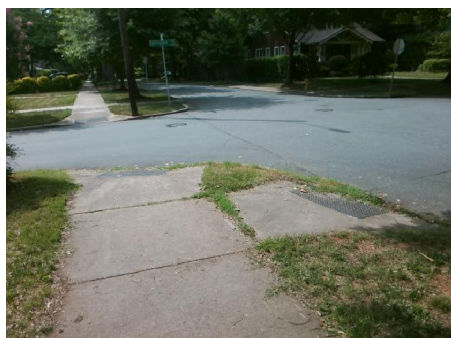
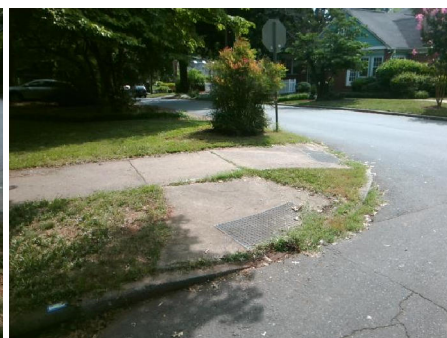
Compliance	Description	Data	Compliance	Description	Data
N/A	Ramp Length (in)	68.0	N/A	Grade Break?	N/A
Yes	Ramp Width (in)	48.0	N/A	Grade Break Slope (%)	0.0
No	Ramp Slope (%)	8.8	N/A	Grade Break XSlope (%)	0.0
No	Ramp XSlope (%)	6.7			
N/A	Flare Type LT	N/A	N/A	Flare Type RT	N/A
N/A	Flare Slope LT (%)	N/A	N/A	Flare Slope RT (%)	0.0
N/A	Flare Traversable LT?	N/A	N/A	Flare Traversable RT?	N/A
N/A	Landing Length (in)	0.0	N/A	DWS Provided?	N/A
N/A	Landing Width (in)	0.0	N/A	DWS Contrast?	N/A
N/A	Landing Slope (%)	0.0	N/A	DWS Length (in)	N/A
N/A	Landing X Slope (%)	0.0	N/A	DWS Full Width?	N/A
N/A	Landing Curb? (Y/N)	N/A	N/A	DWS Offset LT (in)	N/A
N/A	Shared Landing?	N/A	N/A	DWS Offset RT (in)	N/A
N/A	Gutter Ponding?	Yes	N/A	Gutter Slope (%)	N/A
N/A	Gutter Lip Ht (in)	0.0	N/A	Gutter X Slope (%)	N/A
N/A	Painted X Walk1?	No		Road Slope (%)	8.0
	X Walk 1 Direction	To SW		Road X Slope (%)	0.2
	X Walk 1 Width (in)	N/A		Clear Space?	N/A

X Walk 1 Slope (%)	8.0	N/A	Clear Space to XWalk (in)	N/A
	X Walk 1 X Slope (%)	0.2	N/A	Storm Grate/Utility Hazard?	N/A
N/A	Ramp inside XWalk1?	N/A		Storm Grate/Utility Type	
N/A	Any Obstructions?	N/A			N/A
	Obstruction Type		Yes	Surface Condition? (G/P)	Good
			N/A	Curb Slope (%)	0.2

**Remove & Replace Entire Ramp.**

**R304.2.2, R304.5.3**

\$ 1600.00
