# Access Compliance Report

## Public Rights-of-Way

### (Curb Ramps)

| ADA ID: 3DBBACDF1AA8 | Ramp Type: Perp | Initial Pass/Fail: Fail | Overall Compliance: No |

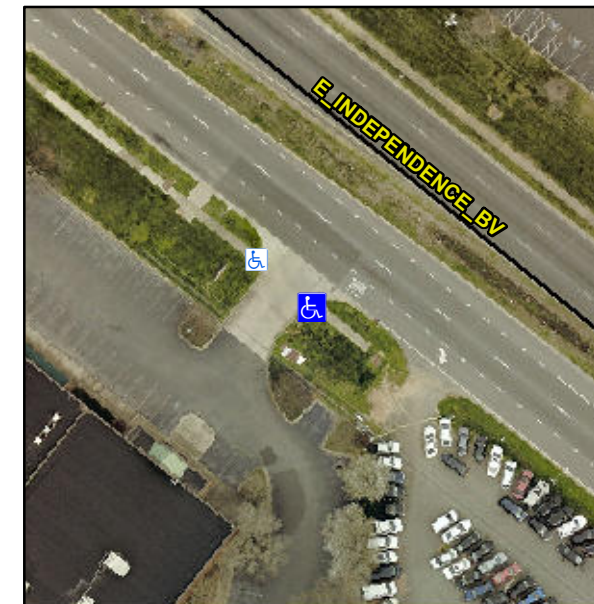
| | | Severity Score: 25 | |

**Not Found, R304.5.3**

| Compliance | Description | Data | Compliance | Description | Data |
|---|---|---|---|---|---|
| Yes | Ramp Width (in) | 48.0 | No | Ramp XSlope (%) | 7.8 |

**Remove & Replace Entire Ramp.**

Total Cost: \$ 1850.00
