Access Compliance Report

Public Rights-of-Way

(Curb Ramps)

Intersection ID: 11423	Main Street: S SUMMIT_AV	Cross Street: W 4TH_ST_EXT	Location: NE
ADA ID: 3DBE8E4EA83D	Ramp Type: Directional1	Initial Pass/Fail: Pass	Overall Compliance: No
		Severity Score: 0

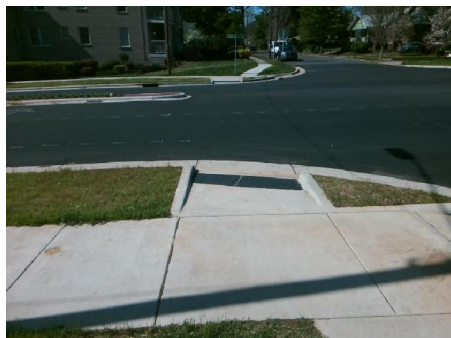
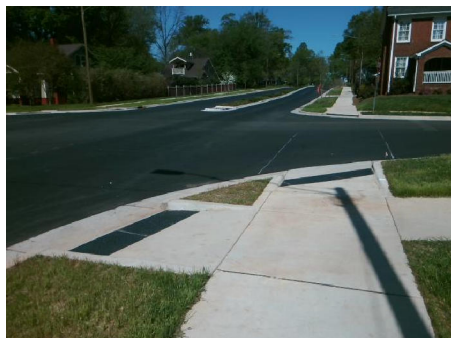
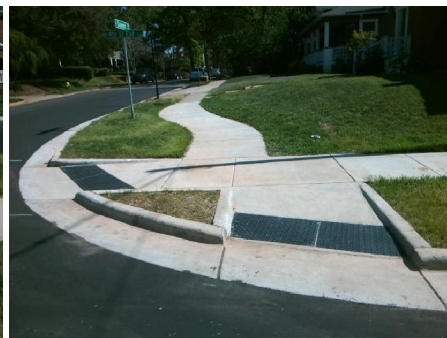
Compliance	Description	Data	Compliance	Description	Data
N/A	Ramp Length (in)	60.0	No	Grade Break?	No
Yes	Ramp Width (in)	70.0	N/A	Grade Break Slope (%)	N/A
Yes	Ramp Slope (%)	7.4	N/A	Grade Break XSlope (%)	N/A
Yes	Ramp XSlope (%)	1.3			
Yes	Flare Type LT	N/A	Yes	Flare Type RT	N/A
N/A	Flare Slope LT (%)	N/A	N/A	Flare Slope RT (%)	N/A
N/A	Flare Traversable LT?	No	N/A	Flare Traversable RT?	No
Yes	Landing Length (in)	71.0	Yes	DWS Provided?	Yes
Yes	Landing Width (in)	70.0	Yes	DWS Contrast?	Yes
Yes	Landing Slope (%)	1.0	Yes	DWS Length (in)	24.0
Yes	Landing X Slope (%)	0.4	Yes	DWS Full Width?	Yes
N/A	Landing Curb? (Y/N)	N/A	Yes	DWS Offset LT (in)	0.0
N/A	Shared Landing?	Yes	Yes	DWS Offset RT (in)	0.0
Yes	Gutter Ponding?	No	Yes	Gutter Slope (%)	0.3
Yes	Gutter Lip Ht (in)	0.0	Yes	Gutter X Slope (%)	2.5
N/A	Painted X Walk1?	No		Road Slope (%)	0.2
	X Walk 1 Direction	To SW		Road X Slope (%)	3.1
	X Walk 1 Width (in)	N/A		Clear Space?	Yes

X Walk 1 Slope (%)	0.2	N/A	Clear Space to XWalk (in)	N/A
	X Walk 1 X Slope (%)	3.1	Yes	Storm Grate/Utility Hazard?	No
N/A	Ramp inside XWalk1?	N/A		Storm Grate/Utility Type	
Yes	Any Obstructions?	No			N/A
	Obstruction Type		Yes	Surface Condition? (G/P)	Good
			N/A	Curb Slope (%)	4.0

Possible Solutions:

Remove & Replace Entire Ramp.
