Access Compliance Report

Public Rights-of-Way

(Curb Ramps)

Intersection ID: 46813	Main Street: ARBOR_VISTA_DR	Cross Street: OLDE_IVY_WY	Location: NE
ADA ID: 3DC51DEDF416	Ramp Type: PerpDiag	Initial Pass/Fail: Fail	Overall Compliance: No
Severity Score: 8.75			
Codes/Mitigation Info/Possible Solution		Field Measurements/Component Compliance

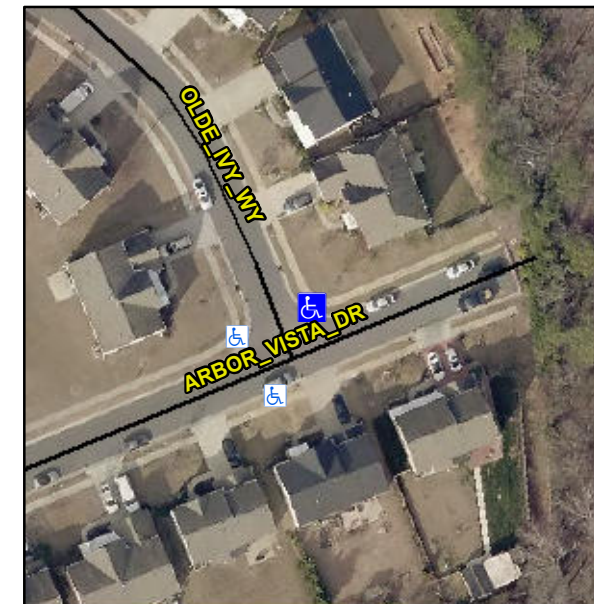
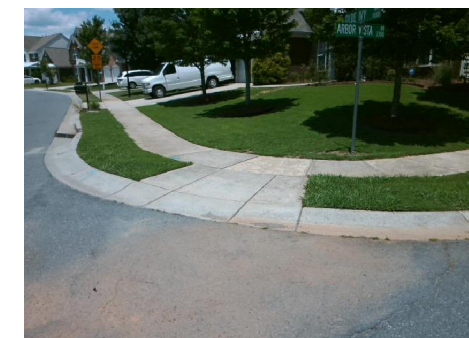
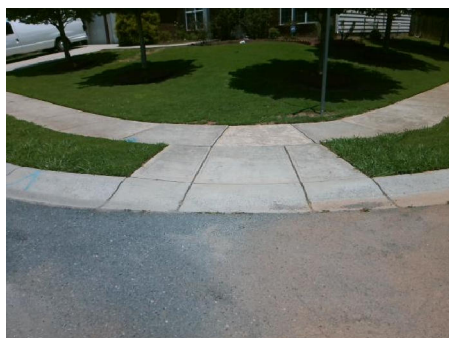
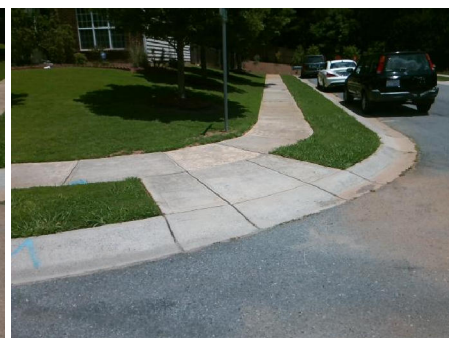
Not Found, R304.5.1

Compliance	Description	Data	Compliance	Description	Data
N/A	Ramp Length (in)	47.5	Yes	Ramp Slope (%)	5.9
No	Ramp Width (in)	39.5	Yes	Ramp XSlope (%)	0.1
N/A	Flare Type LT	N/A	N/A	Flare Type RT	N/A
N/A	Flare Slope LT (%)	N/A	N/A	Flare Slope RT (%)	N/A
N/A	Flare Traversable LT?	N/A	N/A	Flare Traversable RT?	N/A
N/A	Landing Length (in)	N/A	N/A	DWS Provided?	N/A
N/A	Landing Width (in)	N/A	N/A	DWS Contrast?	N/A
N/A	Landing Slope (%)	N/A	N/A	DWS Length (in)	N/A
N/A	Landing X Slope (%)	N/A	N/A	DWS Full Width?	N/A
N/A	Landing Curb? (Y/N)	N/A	N/A	DWS Offset (in)	N/A
N/A	Shared Landing?	N/A			
N/A	Gutter Ponding?	N/A	N/A	Gutter Slope (%)	N/A
N/A	Gutter Lip Ht (in)	N/A	N/A	Gutter X Slope (%)	N/A
N/A	Painted X Walk1?	No	N/A	Painted X Walk2?	No
	X Walk 1 Direction	To W		X Walk 2 Direction	To S
N/A	X Walk 1 Width (in)	N/A	N/A	X Walk 2 Width (in)	N/A
	X Walk 1 Slope (%)	1.0		X Walk 2 Slope (%)	0.4
	X Walk 1 X Slope (%)	1.1		X Walk 2 X Slope (%)	0.1

N/A	Ramp inside XWalk1?	N/A	N/A	Ramp inside XWalk2?	N/A
	Road Slope (%)	0.4	N/A	Clear Space?	N/A
	Road X Slope (%)	0.0	N/A	Clear Space to XWalk (in)	N/A
N/A	Any Obstructions?	N/A	N/A	Storm Grate/Utility Hazard?	N/A
	Obstruction Type			Storm Grate/Utility Type	
		N/A			N/A
		Yes		Surface Condition? (G/P)	Good

Remove & Replace Curb Ramp With Two New Directional Ramps or Equivalent.
