Access Compliance Report

Public Rights-of-Way (Curb Ramps)

Intersection ID: 48410	Main Street: CAIRNS_MILL_CT	Cross Street: BELMAR_PLACE_RD	Location: SW
ADA ID: 3DC6878074A5	Ramp Type: PerpDiag	Initial Pass/Fail: Fail	Overall Compliance: No
Codes/Mitigation Info/Possible Solution		Field Measurements/Component Compliance	
Severity Score: 48.75

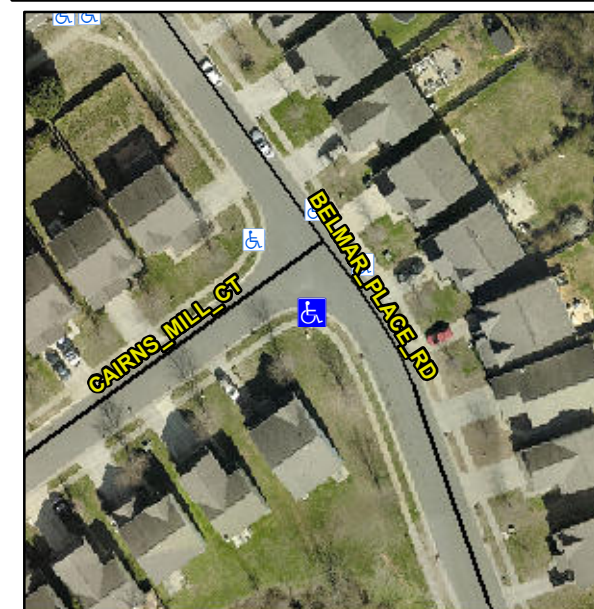
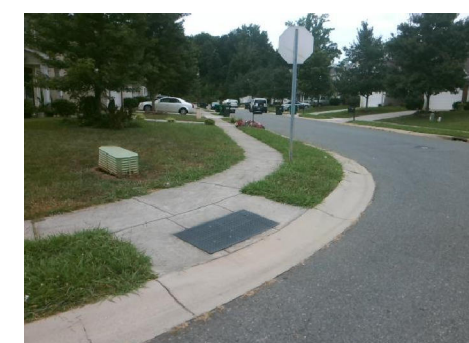
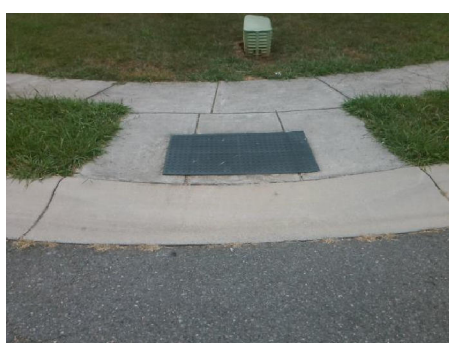
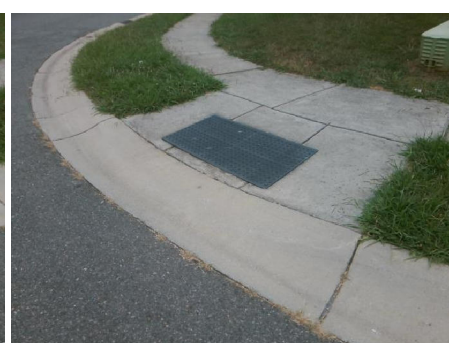
Not Found, R304.5.1, R304.2.2, R304.5.3

Compliance	Description	Data	Compliance	Description	Data
N/A	Ramp Length (in)	48.0	No	Ramp Slope (%)	11.8
No	Ramp Width (in)	31.0	No	Ramp XSlope (%)	3.6
N/A	Flare Type LT	N/A	N/A	Flare Type RT	N/A
N/A	Flare Slope LT (%)	N/A	N/A	Flare Slope RT (%)	N/A
N/A	Flare Traversable LT?	N/A	N/A	Flare Traversable RT?	N/A
N/A	Landing Length (in)	N/A	N/A	DWS Provided?	N/A
N/A	Landing Width (in)	N/A	N/A	DWS Contrast?	N/A
N/A	Landing Slope (%)	N/A	N/A	DWS Length (in)	N/A
N/A	Landing X Slope (%)	N/A	N/A	DWS Full Width?	N/A
N/A	Landing Curb? (Y/N)	N/A	N/A	DWS Offset (in)	N/A
N/A	Shared Landing?	N/A			
N/A	Gutter Ponding?	N/A	N/A	Gutter Slope (%)	N/A
N/A	Gutter Lip Ht (in)	N/A	N/A	Gutter X Slope (%)	N/A
N/A	Painted X Walk1?	No	N/A	Painted X Walk2?	No
	X Walk 1 Direction	To NE		X Walk 2 Direction	To NW
N/A	X Walk 1 Width (in)	N/A	N/A	X Walk 2 Width (in)	N/A
	X Walk 1 Slope (%)	1.8		X Walk 2 Slope (%)	3.2
	X Walk 1 X Slope (%)	3.9		X Walk 2 X Slope (%)	0.0

N/A	Ramp inside XWalk1?	N/A	N/A	Ramp inside XWalk2?	N/A
	Road Slope (%)	3.0	N/A	Clear Space?	N/A
	Road X Slope (%)	2.5	N/A	Clear Space to XWalk (in)	N/A
N/A	Any Obstructions?	N/A	N/A	Storm Grate/Utility Hazard?	N/A
	Obstruction Type			Storm Grate/Utility Type	
		N/A			N/A
			Yes	Surface Condition? (G/P)	Good

Remove & Replace Curb Ramp With Two New Directional Ramps or Equivalent.
