Access Compliance Report

Public Rights-of-Way (Curb Ramps)

Intersection ID: 22358	Main Street: HINSON_DR	Cross Street: TADLOCK_PL	Location: NW
ADA ID: 3DCC67136735	Ramp Type: Directional1	Initial Pass/Fail: Fail	Overall Compliance: No
		Severity Score: 25

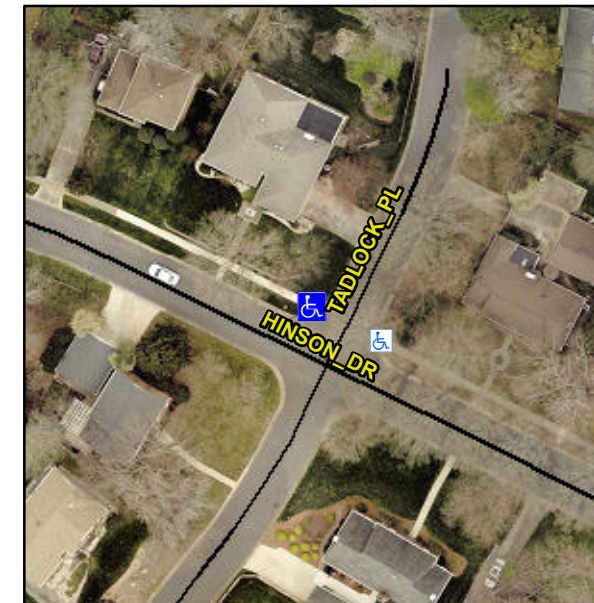
Compliance	Description	Data	Compliance	Description	Data
N/A	Ramp Length (in)	74.0	N/A	Grade Break?	N/A
Yes	Ramp Width (in)	48.0	N/A	Grade Break Slope (%)	0.0
Yes	Ramp Slope (%)	2.4	N/A	Grade Break XSlope (%)	0.0
No	Ramp XSlope (%)	11.3			
N/A	Flare Type LT	N/A	N/A	Flare Type RT	N/A
N/A	Flare Slope LT (%)	N/A	N/A	Flare Slope RT (%)	0.0
N/A	Flare Traversable LT?	N/A	N/A	Flare Traversable RT?	N/A
N/A	Landing Length (in)	0.0	N/A	DWS Provided?	N/A
N/A	Landing Width (in)	0.0	N/A	DWS Contrast?	N/A
N/A	Landing Slope (%)	0.0	N/A	DWS Length (in)	N/A
N/A	Landing X Slope (%)	0.0	N/A	DWS Full Width?	N/A
N/A	Landing Curb? (Y/N)	N/A	N/A	DWS Offset LT (in)	N/A
N/A	Shared Landing?	N/A	N/A	DWS Offset RT (in)	N/A
N/A	Gutter Ponding?	0.0	N/A	Gutter Slope (%)	N/A
N/A	Gutter Lip Ht (in)	0.0	N/A	Gutter X Slope (%)	N/A
N/A	Painted X Walk1?	No		Road Slope (%)	6.1
	X Walk 1 Direction	To E		Road X Slope (%)	3.7
	X Walk 1 Width (in)	N/A		Clear Space?	N/A

X Walk 1 Slope (%)	6.1	N/A	Clear Space to XWalk (in)	N/A
	X Walk 1 X Slope (%)	3.7	N/A	Storm Grate/Utility Hazard?	N/A
N/A	Ramp inside XWalk1?	N/A		Storm Grate/Utility Type	
N/A	Any Obstructions?	N/A			N/A
	Obstruction Type		Yes	Surface Condition? (G/P)	Good
			N/A	Curb Slope (%)	11.3

Possible Solutions:

Remove & Replace Entire Ramp.

R304.5.3

Total Cost: \$ **1600.00**
