Access Compliance Report

Public Rights-of-Way

(Curb Ramps)

Intersection ID: 3933	Main Street: BERSHIRE_LN	Cross Street: LIONSTONE_DR	Location: NW
ADA ID: 3DD418D53919	Ramp Type: Perp	Initial Pass/Fail: Fail	Overall Compliance: No
Severity Score: 33.75			
Codes/Mitigation Info/Possible Solution		Field Measurements/Component Compliance

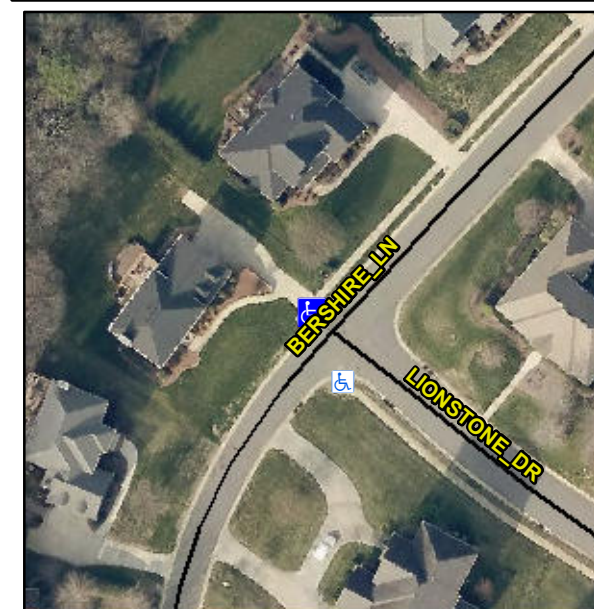
Not Found, R304.5.1, R304.2.2, R304.5.3

Compliance	Description	Data	Compliance	Description	Data
N/A	Ramp Length (in)	49.0	No	Ramp Slope (%)	11.1
No	Ramp Width (in)	45.5	No	Ramp XSlope (%)	6.0
N/A	Flare Type LT	N/A	N/A	Flare Type RT	N/A
N/A	Flare Slope LT (%)	N/A	N/A	Flare Slope RT (%)	N/A
N/A	Flare Traversable LT?	N/A	N/A	Flare Traversable RT?	N/A
N/A	Landing Length (in)	N/A	N/A	DWS Provided?	N/A
N/A	Landing Width (in)	N/A	N/A	DWS Contrast?	N/A
N/A	Landing Slope (%)	N/A	N/A	DWS Length (in)	N/A
N/A	Landing X Slope (%)	N/A	N/A	DWS Full Width?	N/A
N/A	Landing Curb? (Y/N)	N/A	N/A	DWS Offset (in)	N/A
N/A	Shared Landing?	N/A			
N/A	Gutter Ponding?	N/A	N/A	Gutter Slope (%)	N/A
N/A	Gutter Lip Ht (in)	N/A	N/A	Gutter X Slope (%)	N/A
N/A	Painted X Walk1?	No	N/A	Painted X Walk2?	N/A
	X Walk 1 Direction	To S		X Walk 2 Direction	N/A
N/A	X Walk 1 Width (in)	N/A	N/A	X Walk 2 Width (in)	N/A
	X Walk 1 Slope (%)	6.5		X Walk 2 Slope (%)	N/A
	X Walk 1 X Slope (%)	4.5		X Walk 2 X Slope (%)	N/A

N/A	Ramp inside XWalk1?	N/A	N/A	Ramp inside XWalk2?	N/A
	Road Slope (%)	N/A	N/A	Clear Space?	N/A
	Road X Slope (%)	N/A	N/A	Clear Space to XWalk (in)	N/A
N/A	Any Obstructions?	N/A	N/A	Storm Grate/Utility Hazard?	N/A
	Obstruction Type			Storm Grate/Utility Type	
		N/A			N/A
			Yes	Surface Condition? (G/P)	Good

Remove & Replace Entire Ramp.
