Access Compliance Report

Public Rights-of-Way

(Curb Ramps)

Intersection ID: 27798	Main Street: BRIARWICK_LN	Cross Street: BUFFTON_CT	Location: SW
ADA ID: 3DD88B9D16B4	Ramp Type: PerpDiag	Initial Pass/Fail: Fail	Overall Compliance: No
Codes/Mitigation Info/Possible Solution		Field Measurements/Component Compliance	
Severity Score: 12.5

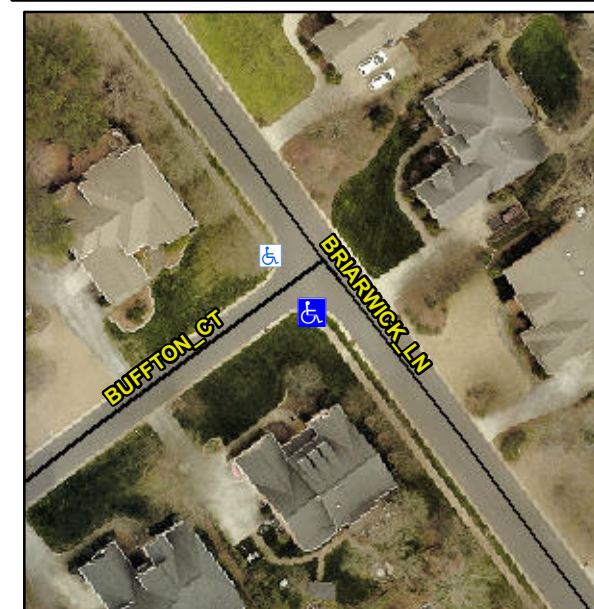
Compliance	Description	Data	Compliance	Description	Data
N/A	Ramp Length (in)	96.0	No	Ramp Slope (%)	8.6
Yes	Ramp Width (in)	48.0	Yes	Ramp XSlope (%)	1.3
N/A	Flare Type LT	N/A	N/A	Flare Type RT	N/A
N/A	Flare Slope LT (%)	N/A	N/A	Flare Slope RT (%)	N/A
N/A	Flare Traversable LT?	N/A	N/A	Flare Traversable RT?	N/A
N/A	Landing Length (in)	N/A	N/A	DWS Provided?	N/A
N/A	Landing Width (in)	N/A	N/A	DWS Contrast?	N/A
N/A	Landing Slope (%)	N/A	N/A	DWS Length (in)	N/A
N/A	Landing X Slope (%)	N/A	N/A	DWS Full Width?	N/A
N/A	Landing Curb? (Y/N)	N/A	N/A	DWS Offset (in)	N/A
N/A	Shared Landing?	N/A			
N/A	Gutter Ponding?	N/A	N/A	Gutter Slope (%)	N/A
N/A	Gutter Lip Ht (in)	N/A	N/A	Gutter X Slope (%)	N/A
N/A	Painted X Walk1?	No	N/A	Painted X Walk2?	No
	X Walk 1 Direction	To NE		X Walk 2 Direction	To NW
N/A	X Walk 1 Width (in)	N/A	N/A	X Walk 2 Width (in)	N/A
	X Walk 1 Slope (%)	2.0		X Walk 2 Slope (%)	1.1
	X Walk 1 X Slope (%)	1.3		X Walk 2 X Slope (%)	0.5

N/A	Ramp inside XWalk1?	N/A	N/A	Ramp inside XWalk2?	N/A
	Road Slope (%)	1.3	N/A	Clear Space?	N/A
	Road X Slope (%)	2.7	N/A	Clear Space to XWalk (in)	N/A
N/A	Any Obstructions?	N/A	N/A	Storm Grate/Utility Hazard?	N/A
	Obstruction Type			Storm Grate/Utility Type	
		N/A			N/A
			Yes	Surface Condition? (G/P)	Good

Remove & Replace Curb Ramp With Two New Directional Ramps or Equivalent.

R304.2.2
