## Access Compliance Report Public Rights-of-Way (Curb Ramps)

Intersection ID: 10898Main Street:E\_23RD\_STCross Street:N\_BREVARD\_STLocation:NADA ID: 3DD9C583C561Ramp Type:PerpInitial Pass/Fail:PassOverall Compliance:NoSeverity Score:0.25

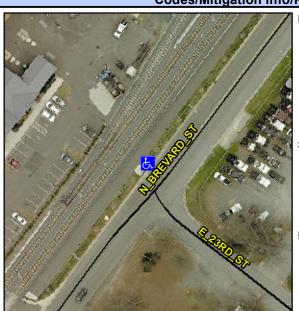
Field Measurements/Component Compliance					
Compliance Description		Data	Comp	liance Description	Data
N/A	Ramp Length (in)	121.0	Yes	Ramp Slope (%)	6.7
Yes	Ramp Width (in)	91.0	No	Ramp XSlope (%)	2.4
Yes	Yes Flare Type LCurbed_NoWalkSurface		Yes	Flare Type RT	N/A
Yes	Flare Slope LT (%)	N/A	N/A	Flare Slope RT (%)	N/A
N/A	Flare Traversable LT?	No	N/A	Flare Traversable RT?	No
Yes	Landing Length (in)	60.0	Yes	DWS Provided?	Yes
Yes	Landing Width (in)	91.0	Yes	DWS Contrast?	Yes
Yes	Landing Slope (%)	1.7	No	DWS Length (in)	21.0
Yes	Landing X Slope (%)	1.3	Yes	DWS Full Width?	Yes
N/A	Landing Curb? (Y/N)	Yes	Yes	DWS Offset (in)	0.0
N/A	Shared Landing?	No			
Yes	Gutter Ponding?	No	Yes	Gutter Slope (%)	3.6
Yes	Gutter Lip Ht (in)	0.0	Yes	Gutter X Slope (%)	2.0
N/A	Painted X Walk1?	No	N/A	Painted X Walk2?	N/A
	X Walk 1 Direction	To SE		X Walk 2 Direction	N/A
N/A	X Walk 1 Width (in)	N/A	N/A	X Walk 2 Width (in)	N/A
	X Walk 1 Slope (%)	1.6		X Walk 2 Slope (%)	N/A

X Walk 1 X Slope (%)	2.3		X Walk 2 X Slope (%)	N/A
N/A	Ramp inside XWalk1?	N/A	N/A	Ramp inside XWalk2?	N/A
	Road Slope (%)	N/A	N/A	Clear Space?	Yes
	Road X Slope (%)	N/A	N/A	Clear Space to XWalk (in)	N/A
Yes	Any Obstructions?	No	Yes	Storm Grate/Utility Hazard?	No
	Obstruction Type			Storm Grate/Utility Type	
		N/A			N/A
			Yes	Surface Condition? (G/P)	Good
表导力

Possible Solutions:

Remove & Replace Entire Ramp.

R304.5.3, R305.1.4
