Access Compliance Report

Public Rights-of-Way

(Curb Ramps)

Intersection ID: 10270	Main Street: FONTANA_AV	Cross Street: SPRING_ST	Location: NW
ADA ID: 3DDF83A8059E	Ramp Type: Perp	Initial Pass/Fail: Fail	Overall Compliance: No
			Severity Score: 26.25

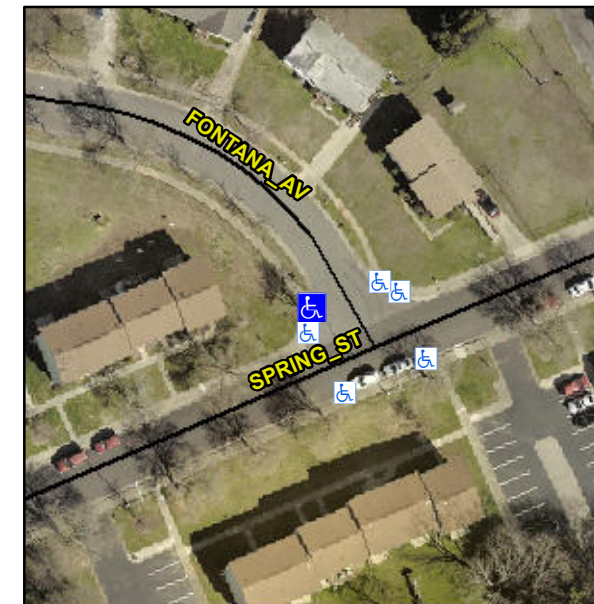
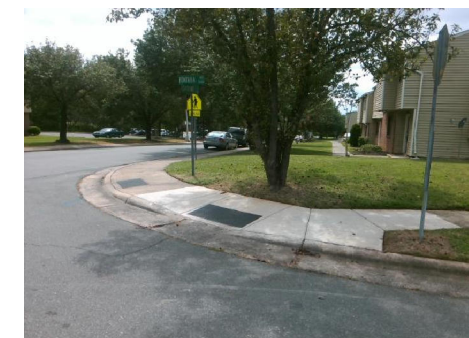
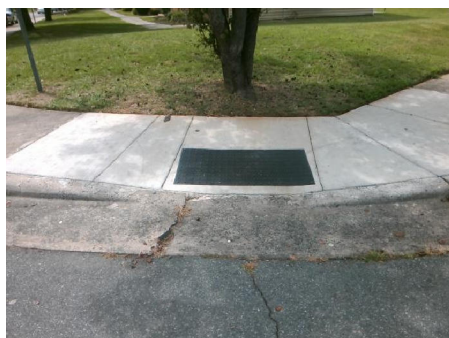
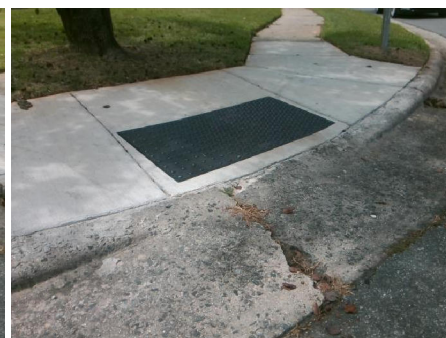
Not Found, R304.2.2, R304.5.3

Compliance	Description	Data	Compliance	Description	Data
N/A	Ramp Length (in)	57.0	No	Ramp Slope (%)	12.0
Yes	Ramp Width (in)	52.0	No	Ramp XSlope (%)	3.0
N/A	Flare Type LT	N/A	N/A	Flare Type RT	N/A
N/A	Flare Slope LT (%)	N/A	N/A	Flare Slope RT (%)	N/A
N/A	Flare Traversable LT?	N/A	N/A	Flare Traversable RT?	N/A
N/A	Landing Length (in)	N/A	N/A	DWS Provided?	N/A
N/A	Landing Width (in)	N/A	N/A	DWS Contrast?	N/A
N/A	Landing Slope (%)	N/A	N/A	DWS Length (in)	N/A
N/A	Landing X Slope (%)	N/A	N/A	DWS Full Width?	N/A
N/A	Landing Curb? (Y/N)	N/A	N/A	DWS Offset (in)	N/A
N/A	Shared Landing?	N/A			
N/A	Gutter Ponding?	N/A	N/A	Gutter Slope (%)	N/A
N/A	Gutter Lip Ht (in)	2.0	N/A	Gutter X Slope (%)	N/A
N/A	Painted X Walk1?	No	N/A	Painted X Walk2?	N/A
	X Walk 1 Direction	To E		X Walk 2 Direction	N/A
N/A	X Walk 1 Width (in)	N/A	N/A	X Walk 2 Width (in)	N/A
	X Walk 1 Slope (%)	2.3		X Walk 2 Slope (%)	N/A
	X Walk 1 X Slope (%)	1.8		X Walk 2 X Slope (%)	N/A

Remove & Replace Entire Ramp.
