Intersection ID: 10034403		Main Street: PIEDMONT_ROW_DR_SOUTH		Cross Street: N/A		Location:		NW			
ADA ID: 3DE9322FF596		Ramp Type: PerpDiag		Initial Pass/Fail: Fail		Overall Compliance: No		Severity Score: 21.25			
Codes/Mitigation Info/Possible Solution				Field Measurements/Component Compliance

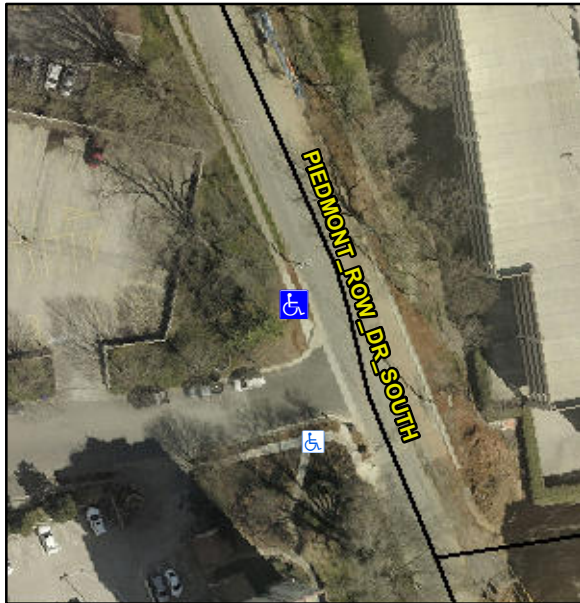
N/A		Painted X Walk1?		No	
								X Walk 1 Direction		To S	
						N/A		X Walk 1 Width (in)		N/A	
								X Walk 1 Slope (%)		4.5	
								X Walk 1 X Slope (%)		8.9	
						N/A		Ramp inside XWalk1?		N/A	
								Road Slope (%)		1.4	
								Road X Slope (%)		13.1	
						N/A		Any Obstructions?		N/A	
								Obstruction Type			
Total Cost: \$ 3200.00										N/A	
										Yes

Possible Solutions:		Compliance		Description		Data	
				Remove & Replace Curb Ramp With Two New Directional Ramps or Equivalent.		N/A		Ramp Length (in)		50.0	
Surveyor Notes:				N/A		No		Ramp Width (in)		41.0	
						N/A		Flare Type LT		N/A	
PROW/ADA:						N/A		Flare Slope LT (%)		N/A	
						N/A		Flare Traversable LT?		N/A	
Not Found, R304.5.1, R304.2.2						N/A		Landing Length (in)		N/A	
						N/A		Landing Width (in)		N/A	
						N/A		Landing Slope (%)		N/A	
						N/A		Landing X Slope (%)		N/A	
						N/A		Landing Curb? (Y/N)		N/A	
						N/A		Shared Landing?		N/A	
						N/A		Gutter Ponding?		N/A	
						N/A		Gutter Lip Ht (in)		N/A
