Access Compliance Report Public Rights-of-Way (Curb Ramps)

Intersection ID: 16305 Main Street: E_PETERSON_DR Cross Street: S_TRYON_ST Location: N

ADA ID: 3E05FC5CD632 Ramp Type: PerpDiag Initial Pass/Fail: Fail Overall Compliance: No Severity Score: 31.25

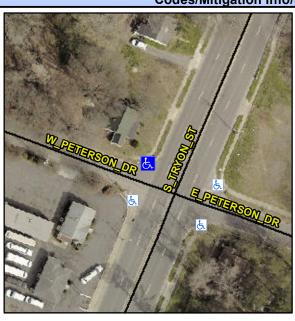
Compliance Description		Data	Compliance Description		Data
N/A	Ramp Length (in)	108.0	No	Ramp Slope (%)	9.3
No	Ramp Width (in)	33.0	No	Ramp XSlope (%)	2.7
N/A	Flare Type LT	N/A	N/A	Flare Type RT	N/A
N/A	Flare Slope LT (%)	N/A	N/A	Flare Slope RT (%)	N/A
N/A	Flare Traversable LT?	N/A	N/A	Flare Traversable RT?	N/A
N/A	Landing Length (in)	N/A	N/A	DWS Provided?	N/A
N/A	Landing Width (in)	N/A	N/A	DWS Contrast?	N/A
N/A	Landing Slope (%)	N/A	N/A	DWS Length (in)	N/A
N/A	Landing X Slope (%)	N/A	N/A	DWS Full Width?	N/A
N/A	Landing Curb? (Y/N)	N/A	N/A	DWS Offset (in)	N/A
N/A	Shared Landing?	N/A			
N/A	Gutter Ponding?	N/A	N/A	Gutter Slope (%)	N/A
N/A	Gutter Lip Ht (in)	N/A	N/A	Gutter X Slope (%)	N/A
N/A	Painted X Walk1?	No	N/A	Painted X Walk2?	No
	X Walk 1 Direction	To SW		X Walk 2 Direction	To SE
N/A	X Walk 1 Width (in)	N/A	N/A	X Walk 2 Width (in)	N/A
	X Walk 1 Slope (%)	3.1		X Walk 2 Slope (%)	0.2
	X Walk 1 X Slope (%)	1.6		X Walk 2 X Slope (%)	2.5

Remove & Replace Curb Ramp With
Two New Directional Ramps or
Equivalent.

PROW/ADA:
R304.5.1, R304.2.2, R304.5.3
