Access Compliance Report

Public Rights-of-Way

(Curb Ramps)

Intersection ID: 49397	Main Street: HEREFORD_ST	Cross Street: DAMASCUS_ST	Location: SW
ADA ID: 3E06D76844B1	Ramp Type: BlendTrans1	Initial Pass/Fail: Pass	Overall Compliance: No
		Severity Score: 7.75

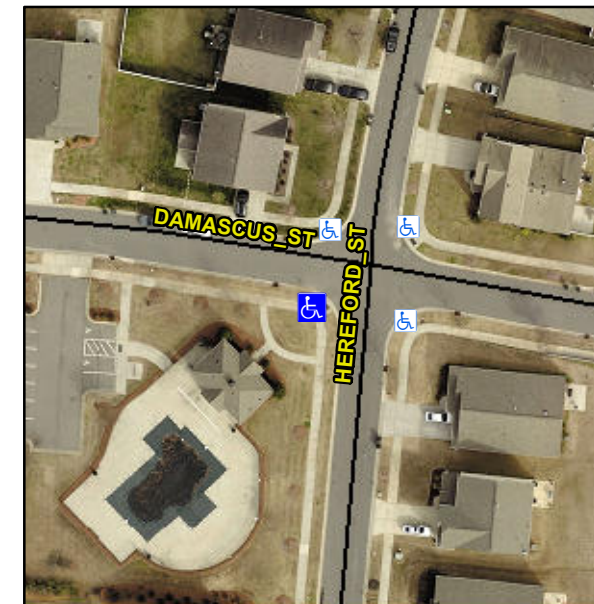
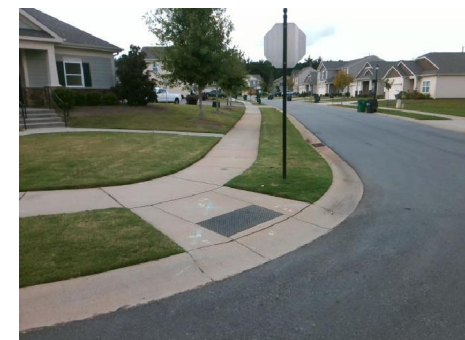
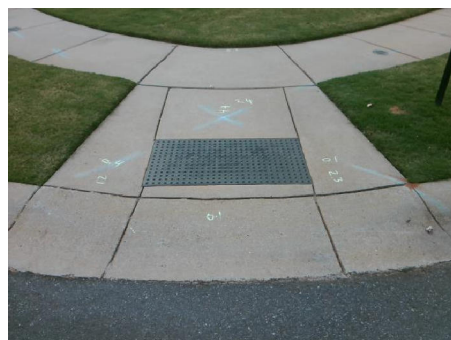
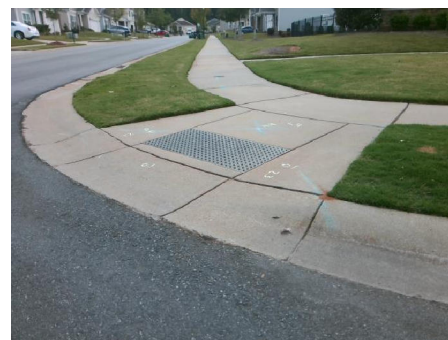
Not Found, R304.5.3, R305.2, R302.7, R302.7.2

Compliance	Description	Data	Compliance	Description	Data
N/A	Ramp Length (in)	71.5	Yes	BlendTrans Slope (%)	4.4
Yes	Ramp Width (in)	48.0	No	BlendTrans XSlope (%)	2.4
N/A	Flare Type LT	Sloped	N/A	Flare Type RT	Sloped
N/A	Flare Slope LT (%)	7.0	N/A	Flare Slope RT (%)	3.2
N/A	Flare Traversable LT?	No	N/A	Flare Traversable RT?	No
Yes	Landing Length (in)	59.0	Yes	DWS Provided?	Yes
Yes	Landing Width (in)	57.0	Yes	DWS Contrast?	Yes
Yes	Landing Slope (%)	1.2	Yes	DWS Length (in)	24.5
Yes	Landing X Slope (%)	1.3	Yes	DWS Full Width?	Yes
N/A	Landing Curb? (Y/N)	No	No	DWS Offset (in)	5.5
N/A	Shared Landing?	No			
No	Gutter Ponding?	Yes	Yes	Gutter Slope (%)	4.8
No	Gutter Lip Ht (in)	0.5	Yes	Gutter X Slope (%)	0.8
N/A	Painted X Walk1?	No	N/A	Painted X Walk2?	No
	X Walk 1 Direction	To E		X Walk 2 Direction	To N
	X Walk 1 Width (in)	N/A		X Walk 2 Width (in)	N/A
	X Walk 1 Slope (%)	2.1		X Walk 2 Slope (%)	2.3
	X Walk 1 X Slope (%)	0.4		X Walk 2 X Slope (%)	0.1

N/A	Ramp inside XWalk1?	N/A	N/A	Ramp inside XWalk2?	N/A
	Road Slope (%)	0.1		Clear Space?	Yes
	Road X Slope (%)	1.7	N/A	Clear Space to XWalk (in)	N/A
Yes	Any Obstructions?	No	Yes	Storm Grate/Utility Hazard?	No
	Obstruction Type			Storm Grate/Utility Type	
		N/A			N/A
			Yes	Surface Condition? (G/P)	Good
			No	Curb Slope (%)	9.9

Possible Solutions:

Remove & Replace Curb Ramp With Two New Directional Ramps or Equivalent.
