Access Compliance Report

Public Rights-of-Way

(Curb Ramps)

Intersection ID: 11431	Main Street: N_GRAHAM_ST	Cross Street: W_9TH_ST	Location:	S
ADA ID: 3E08A6F7AEA8	Ramp Type: PerpDiag	Initial Pass/Fail: Fail	Overall Compliance: No	Severity Score: 25
Codes/Mitigation Info/Possible Solution		Field Measurements/Component Compliance

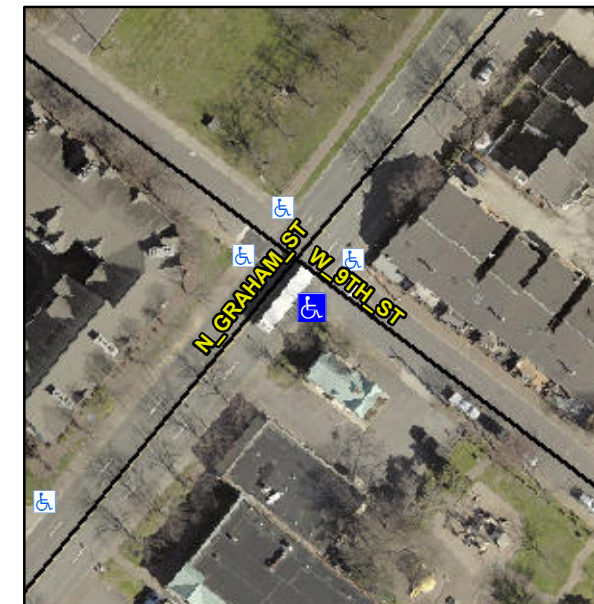
Not Found, R304.2.2

Compliance	Description	Data	Compliance	Description	Data
N/A	Ramp Length (in)	40.0	No	Ramp Slope (%)	12.5
Yes	Ramp Width (in)	48.0	Yes	Ramp XSlope (%)	1.1
N/A	Flare Type LT	N/A	N/A	Flare Type RT	N/A
N/A	Flare Slope LT (%)	N/A	N/A	Flare Slope RT (%)	N/A
N/A	Flare Traversable LT?	N/A	N/A	Flare Traversable RT?	N/A
N/A	Landing Length (in)	N/A	N/A	DWS Provided?	N/A
N/A	Landing Width (in)	N/A	N/A	DWS Contrast?	N/A
N/A	Landing Slope (%)	N/A	N/A	DWS Length (in)	N/A
N/A	Landing X Slope (%)	N/A	N/A	DWS Full Width?	N/A
N/A	Landing Curb? (Y/N)	N/A	N/A	DWS Offset (in)	N/A
N/A	Shared Landing?	N/A			
N/A	Gutter Ponding?	N/A	N/A	Gutter Slope (%)	N/A
N/A	Gutter Lip Ht (in)	N/A	N/A	Gutter X Slope (%)	N/A
N/A	Painted X Walk1?	No	N/A	Painted X Walk2?	No
	X Walk 1 Direction	To NE		X Walk 2 Direction	To NW
N/A	X Walk 1 Width (in)	N/A	N/A	X Walk 2 Width (in)	N/A
	X Walk 1 Slope (%)	4.1		X Walk 2 Slope (%)	0.8
	X Walk 1 X Slope (%)	2.0		X Walk 2 X Slope (%)	0.2

N/A	Ramp inside XWalk1?	N/A	N/A	Ramp inside XWalk2?	N/A
	Road Slope (%)	1.0	N/A	Clear Space?	N/A
	Road X Slope (%)	4.5	N/A	Clear Space to XWalk (in)	N/A
N/A	Any Obstructions?	N/A	N/A	Storm Grate/Utility Hazard?	N/A
	Obstruction Type			Storm Grate/Utility Type	
		N/A			N/A
			Yes	Surface Condition? (G/P)	Good

Remove & Replace Curb Ramp With Two New Directional Ramps or Equivalent.
