Access Compliance Report

Public Rights-of-Way

(Curb Ramps)

Intersection ID: 47643	Main Street: BAMBURGH_CT	Cross Street: WESTON_WOODS_LN	Location: SE
ADA ID: 3E0D547C726A	Ramp Type: PerpDiag	Initial Pass/Fail: Fail	Overall Compliance: No
		Severity Score: 25

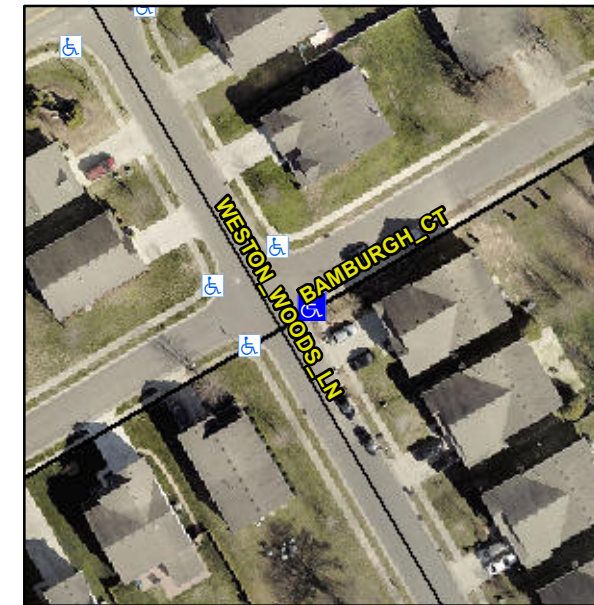
Not Found, R304.5.3

Compliance	Description	Data	Compliance	Description	Data
N/A	Ramp Length (in)	48.0	Yes	Ramp Slope (%)	7.7
Yes	Ramp Width (in)	48.0	No	Ramp XSlope (%)	8.5
N/A	Flare Type LT	N/A	N/A	Flare Type RT	N/A
N/A	Flare Slope LT (%)	N/A	N/A	Flare Slope RT (%)	N/A
N/A	Flare Traversable LT?	N/A	N/A	Flare Traversable RT?	N/A
N/A	Landing Length (in)	N/A	N/A	DWS Provided?	N/A
N/A	Landing Width (in)	N/A	N/A	DWS Contrast?	N/A
N/A	Landing Slope (%)	N/A	N/A	DWS Length (in)	N/A
N/A	Landing X Slope (%)	N/A	N/A	DWS Full Width?	N/A
N/A	Landing Curb? (Y/N)	N/A	N/A	DWS Offset (in)	N/A
N/A	Shared Landing?	N/A			
N/A	Gutter Ponding?	N/A	N/A	Gutter Slope (%)	N/A
N/A	Gutter Lip Ht (in)	N/A	N/A	Gutter X Slope (%)	N/A
N/A	Painted X Walk1?	No	N/A	Painted X Walk2?	No
	X Walk 1 Direction	To NW		X Walk 2 Direction	To SW
N/A	X Walk 1 Width (in)	N/A	N/A	X Walk 2 Width (in)	N/A
	X Walk 1 Slope (%)	4.4		X Walk 2 Slope (%)	2.6
	X Walk 1 X Slope (%)	0.6		X Walk 2 X Slope (%)	1.2

Remove & Replace Curb Ramp With Two New Directional Ramps or Equivalent.
