Access Compliance Report

Public Rights-of-Way

(Curb Ramps)

Intersection ID: 12433	Main Street: HARGROVE_AV	Cross Street: MIDLAND_AV	Location: SE
ADA ID: 3E102BD43100	Ramp Type: PerpDiag	Initial Pass/Fail: Fail	Overall Compliance: No
Severity Score: 22.5			
Codes/Mitigation Info/Possible Solution		Field Measurements/Component Compliance

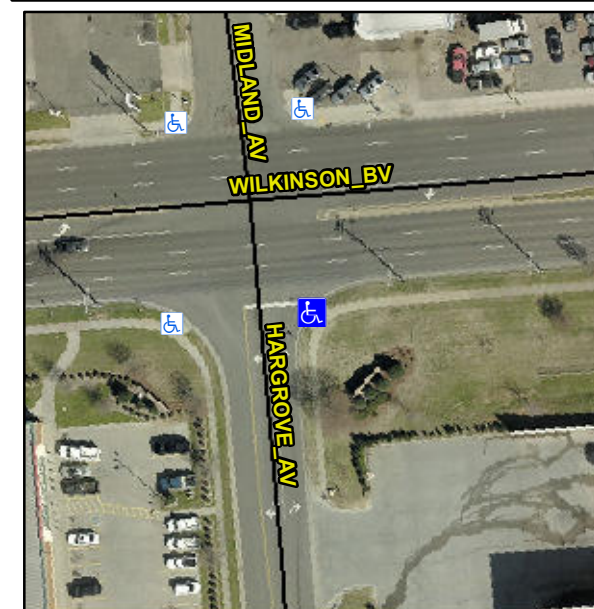
Not Found, R304.5.1, R304.2.2, R304.5.3

Compliance	Description	Data	Compliance	Description	Data
N/A	Ramp Length (in)	60.0	No	Ramp Slope (%)	8.7
No	Ramp Width (in)	41.0	No	Ramp XSlope (%)	2.5
N/A	Flare Type LT	N/A	N/A	Flare Type RT	N/A
N/A	Flare Slope LT (%)	N/A	N/A	Flare Slope RT (%)	N/A
N/A	Flare Traversable LT?	N/A	N/A	Flare Traversable RT?	N/A
N/A	Landing Length (in)	N/A	N/A	DWS Provided?	N/A
N/A	Landing Width (in)	N/A	N/A	DWS Contrast?	N/A
N/A	Landing Slope (%)	N/A	N/A	DWS Length (in)	N/A
N/A	Landing X Slope (%)	N/A	N/A	DWS Full Width?	N/A
N/A	Landing Curb? (Y/N)	N/A	N/A	DWS Offset (in)	N/A
N/A	Shared Landing?	N/A			
N/A	Gutter Ponding?	N/A	N/A	Gutter Slope (%)	N/A
N/A	Gutter Lip Ht (in)	N/A	N/A	Gutter X Slope (%)	N/A
N/A	Painted X Walk1?	No	N/A	Painted X Walk2?	No
	X Walk 1 Direction	To N		X Walk 2 Direction	To W
N/A	X Walk 1 Width (in)	N/A	N/A	X Walk 2 Width (in)	N/A
	X Walk 1 Slope (%)	5.4		X Walk 2 Slope (%)	2.0
	X Walk 1 X Slope (%)	0.2		X Walk 2 X Slope (%)	4.1

N/A	Ramp inside XWalk1?	N/A	N/A	Ramp inside XWalk2?	N/A
	Road Slope (%)	3.6	N/A	Clear Space?	N/A
	Road X Slope (%)	1.9	N/A	Clear Space to XWalk (in)	N/A
N/A	Any Obstructions?	N/A	N/A	Storm Grate/Utility Hazard?	N/A
	Obstruction Type			Storm Grate/Utility Type	
		N/A			N/A
		Yes		Surface Condition? (G/P)	Good

Remove & Replace Curb Ramp With Two New Directional Ramps or Equivalent.
