# Access Compliance Report

## Public Rights-of-Way (Curb Ramps)

Intersection ID: 52442	Main Street: WOODWARD_AV	Cross Street: BENDING_BIRCH_PL	Location: SE
ADA ID: 3E1CE0695115	Ramp Type: Directional1	Initial Pass/Fail: Fail	Overall Compliance: No
Severity Score: 13.75			
Codes/Mitigation Info/Possible Solution		Field Measurements/Component Compliance

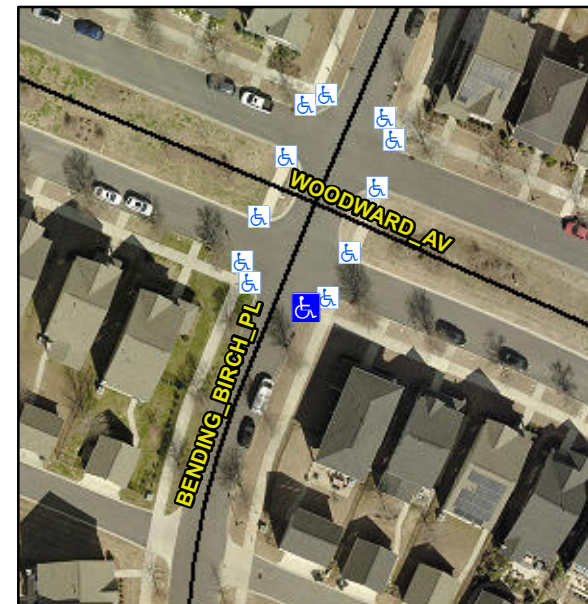
Compliance	Description	Data	Compliance	Description	Data
N/A	Ramp Length (in)	<b>79.0</b>	N/A	Grade Break?	<b>N/A</b>
Yes	Ramp Width (in)	<b>59.5</b>	N/A	Grade Break Slope (%)	<b>0.0</b>
No	Ramp Slope (%)	<b>9.7</b>	N/A	Grade Break XSlope (%)	<b>0.0</b>
No	Ramp XSlope (%)	<b>5.0</b>			
N/A	Flare Type LT	<b>N/A</b>	N/A	Flare Type RT	<b>N/A</b>
N/A	Flare Slope LT (%)	<b>N/A</b>	N/A	Flare Slope RT (%)	<b>0.0</b>
N/A	Flare Traversable LT?	<b>N/A</b>	N/A	Flare Traversable RT?	<b>N/A</b>
N/A	Landing Length (in)	<b>0.0</b>	N/A	DWS Provided?	<b>N/A</b>
N/A	Landing Width (in)	<b>0.0</b>	N/A	DWS Contrast?	<b>N/A</b>
N/A	Landing Slope (%)	<b>0.0</b>	N/A	DWS Length (in)	<b>N/A</b>
N/A	Landing X Slope (%)	<b>0.0</b>	N/A	DWS Full Width?	<b>N/A</b>
N/A	Landing Curb? (Y/N)	<b>N/A</b>	N/A	DWS Offset LT (in)	<b>N/A</b>
N/A	Shared Landing?	<b>N/A</b>	N/A	DWS Offset RT (in)	<b>N/A</b>
N/A	Gutter Ponding?	<b>0.0</b>	N/A	Gutter Slope (%)	<b>N/A</b>

N/A	Gutter Lip Ht (in)	<b>3.0</b>	N/A	Gutter X Slope (%)	<b>N/A</b>
N/A	Painted X Walk1?	<b>No</b>		Road Slope (%)	<b>0.5</b>
	X Walk 1 Direction	<b>To W</b>		Road X Slope (%)	<b>4.2</b>
	X Walk 1 Width (in)	<b>N/A</b>		Clear Space?	<b>N/A</b>
	X Walk 1 Slope (%)	<b>0.5</b>	N/A	Clear Space to XWalk (in)	<b>N/A</b>
	X Walk 1 X Slope (%)	<b>4.2</b>	N/A	Storm Grate/Utility Hazard?	<b>N/A</b>
N/A	Ramp inside XWalk1?	<b>N/A</b>		Storm Grate/Utility Type	
N/A	Any Obstructions?	<b>N/A</b>			<b>N/A</b>
	Obstruction Type		Yes	Surface Condition? (G/P)	<b>Good</b>
			N/A	Curb Slope (%)	<b>12.7</b>

**Remove & Replace Entire Ramp.**
