Access Compliance Report

Public Rights-of-Way

(Curb Ramps)

Intersection ID: 11255	Main Street: ATTABERRY_DR	Cross Street: MATHESON_AV	Location: W
ADA ID: 3E1EB1972C48	Ramp Type: PerpDiag	Initial Pass/Fail: Fail	Overall Compliance: No
		Severity Score: 22.5

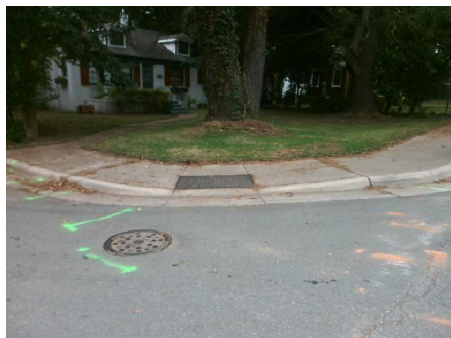
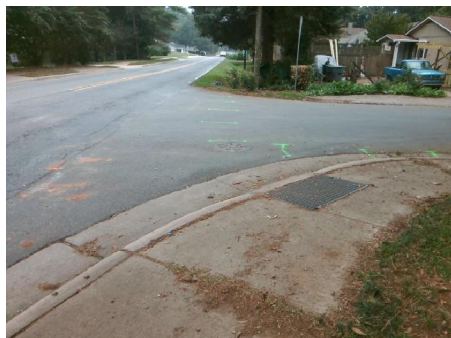
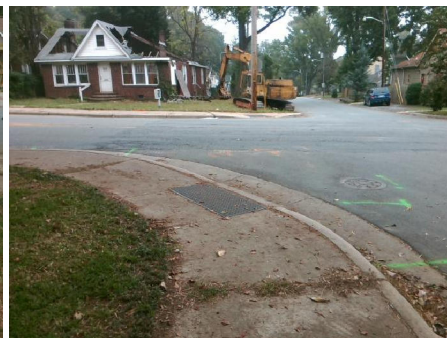
Not Found, R304.5.1, R304.2.2, R304.5.3

Compliance	Description	Data	Compliance	Description	Data
N/A	Ramp Length (in)	59.5	No	Ramp Slope (%)	9.1
No	Ramp Width (in)	41.0	No	Ramp XSlope (%)	4.2
N/A	Flare Type LT	N/A	N/A	Flare Type RT	N/A
N/A	Flare Slope LT (%)	N/A	N/A	Flare Slope RT (%)	N/A
N/A	Flare Traversable LT?	N/A	N/A	Flare Traversable RT?	N/A
N/A	Landing Length (in)	N/A	N/A	DWS Provided?	N/A
N/A	Landing Width (in)	N/A	N/A	DWS Contrast?	N/A
N/A	Landing Slope (%)	N/A	N/A	DWS Length (in)	N/A
N/A	Landing X Slope (%)	N/A	N/A	DWS Full Width?	N/A
N/A	Landing Curb? (Y/N)	N/A	N/A	DWS Offset (in)	N/A
N/A	Shared Landing?	N/A			
N/A	Gutter Ponding?	N/A	N/A	Gutter Slope (%)	N/A
N/A	Gutter Lip Ht (in)	N/A	N/A	Gutter X Slope (%)	N/A
N/A	Painted X Walk1?	No	N/A	Painted X Walk2?	No
	X Walk 1 Direction	To SE		X Walk 2 Direction	To NE
N/A	X Walk 1 Width (in)	N/A	N/A	X Walk 2 Width (in)	N/A
	X Walk 1 Slope (%)	0.0		X Walk 2 Slope (%)	2.3
	X Walk 1 X Slope (%)	0.4		X Walk 2 X Slope (%)	2.9

N/A	Ramp inside XWalk1?	N/A	N/A	Ramp inside XWalk2?	N/A
	Road Slope (%)	3.6	N/A	Clear Space?	N/A
	Road X Slope (%)	2.0	N/A	Clear Space to XWalk (in)	N/A
N/A	Any Obstructions?	N/A	N/A	Storm Grate/Utility Hazard?	N/A
	Obstruction Type			Storm Grate/Utility Type	
		N/A			N/A
			Yes	Surface Condition? (G/P)	Good

Remove & Replace Curb Ramp With Two New Directional Ramps or Equivalent.
