Access Compliance Report

Public Rights-of-Way

(Curb Ramps)

Intersection ID: 46789	Main Street: STOWE_ACRES_DR	Cross Street: WILTON_GATE_DR	Location: NE
ADA ID: 3E2B17EFFF31	Ramp Type: PerpDiag	Initial Pass/Fail: Fail	Overall Compliance: No
Severity Score: 22.5			
Codes/Mitigation Info/Possible Solution		Field Measurements/Component Compliance

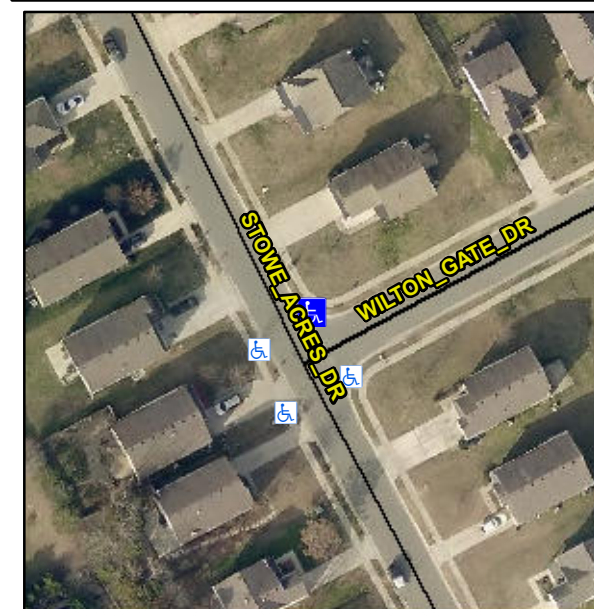
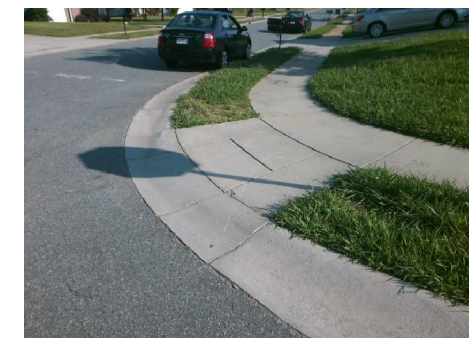
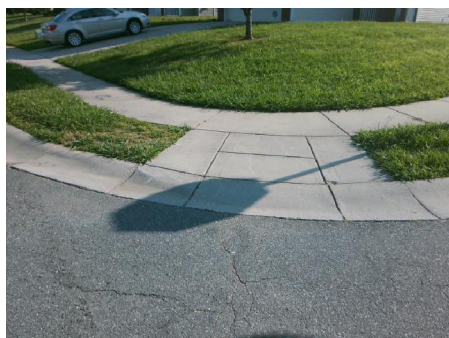
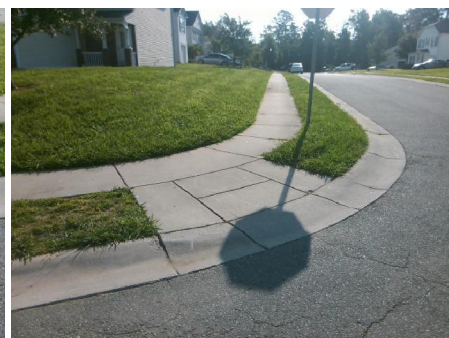
R304.5.1, R304.2.2, R304.5.3

Compliance	Description	Data	Compliance	Description	Data
N/A	Ramp Length (in)	48.5	No	Ramp Slope (%)	9.3
No	Ramp Width (in)	39.0	No	Ramp XSlope (%)	3.2
N/A	Flare Type LT	N/A	N/A	Flare Type RT	N/A
N/A	Flare Slope LT (%)	N/A	N/A	Flare Slope RT (%)	N/A
N/A	Flare Traversable LT?	N/A	N/A	Flare Traversable RT?	N/A
N/A	Landing Length (in)	N/A	N/A	DWS Provided?	N/A
N/A	Landing Width (in)	N/A	N/A	DWS Contrast?	N/A
N/A	Landing Slope (%)	N/A	N/A	DWS Length (in)	N/A
N/A	Landing X Slope (%)	N/A	N/A	DWS Full Width?	N/A
N/A	Landing Curb? (Y/N)	N/A	N/A	DWS Offset (in)	N/A
N/A	Shared Landing?	N/A			
N/A	Gutter Ponding?	N/A	N/A	Gutter Slope (%)	N/A
N/A	Gutter Lip Ht (in)	N/A	N/A	Gutter X Slope (%)	N/A
N/A	Painted X Walk1?	No	N/A	Painted X Walk2?	No
	X Walk 1 Direction	To W		X Walk 2 Direction	To S
N/A	X Walk 1 Width (in)	N/A	N/A	X Walk 2 Width (in)	N/A
	X Walk 1 Slope (%)	0.8		X Walk 2 Slope (%)	0.1
	X Walk 1 X Slope (%)	0.7		X Walk 2 X Slope (%)	1.1

N/A	Ramp inside XWalk1?	N/A	N/A	Ramp inside XWalk2?	N/A
	Road Slope (%)	0.7	N/A	Clear Space?	N/A
	Road X Slope (%)	0.8	N/A	Clear Space to XWalk (in)	N/A
N/A	Any Obstructions?	N/A	N/A	Storm Grate/Utility Hazard?	N/A
	Obstruction Type			Storm Grate/Utility Type	
		N/A			N/A
			Yes	Surface Condition? (G/P)	Good

Remove & Replace Curb Ramp With Two New Directional Ramps or Equivalent.

Total Cost: \$ 3200.00
