# Access Compliance Report

## Public Rights-of-Way

### (Curb Ramps)

Intersection ID: 53895	Main Street: DALLAS_BAY_RD	Cross Street: HAMILTON_BRIDGE_RD	Location: NW
ADA ID: 3E3676D55535	Ramp Type: Perp	Initial Pass/Fail: Fail	Overall Compliance: No
Severity Score: 21.25			
Codes/Mitigation Info/Possible Solution		Field Measurements/Component Compliance

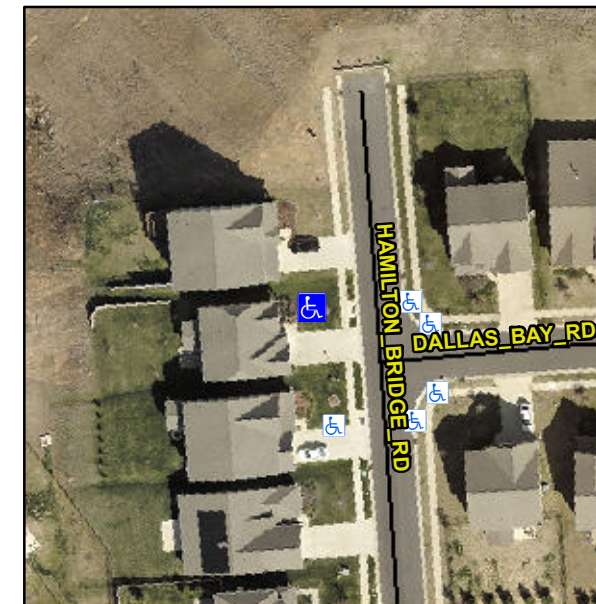
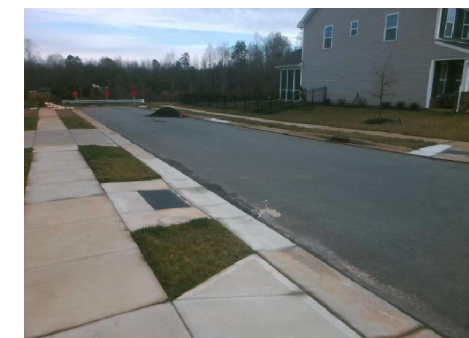
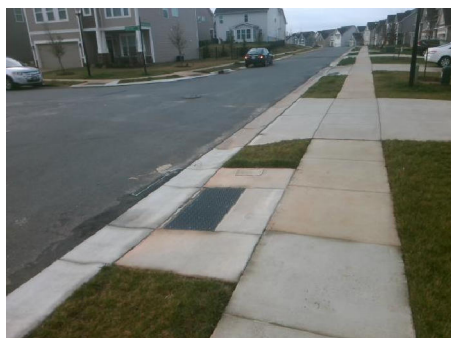
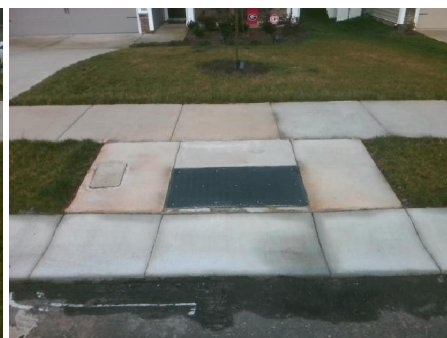
**Not Found, R304.5.1, R304.2.2**

Compliance	Description	Data	Compliance	Description	Data
N/A	Ramp Length (in)	47.5	No	Ramp Slope (%)	11.4
No	Ramp Width (in)	46.5	Yes	Ramp XSlope (%)	0.5
N/A	Flare Type LT	N/A	N/A	Flare Type RT	N/A
N/A	Flare Slope LT (%)	N/A	N/A	Flare Slope RT (%)	N/A
N/A	Flare Traversable LT?	N/A	N/A	Flare Traversable RT?	N/A
N/A	Landing Length (in)	N/A	N/A	DWS Provided?	N/A
N/A	Landing Width (in)	N/A	N/A	DWS Contrast?	N/A
N/A	Landing Slope (%)	N/A	N/A	DWS Length (in)	N/A
N/A	Landing X Slope (%)	N/A	N/A	DWS Full Width?	N/A
N/A	Landing Curb? (Y/N)	N/A	N/A	DWS Offset (in)	N/A
N/A	Shared Landing?	N/A			
N/A	Gutter Ponding?	N/A	N/A	Gutter Slope (%)	N/A
N/A	Gutter Lip Ht (in)	1.5	N/A	Gutter X Slope (%)	N/A
N/A	Painted X Walk1?	No	N/A	Painted X Walk2?	N/A
	X Walk 1 Direction	To E		X Walk 2 Direction	N/A
N/A	X Walk 1 Width (in)	N/A	N/A	X Walk 2 Width (in)	N/A
	X Walk 1 Slope (%)	3.7		X Walk 2 Slope (%)	N/A
	X Walk 1 X Slope (%)	0.7		X Walk 2 X Slope (%)	N/A

N/A	Ramp inside XWalk1?	N/A	N/A	Ramp inside XWalk2?	N/A
	Road Slope (%)	N/A	N/A	Clear Space?	N/A
	Road X Slope (%)	N/A	N/A	Clear Space to XWalk (in)	N/A
N/A	Any Obstructions?	N/A	N/A	Storm Grate/Utility Hazard?	N/A
	Obstruction Type			Storm Grate/Utility Type	
		N/A			N/A
			Yes	Surface Condition? (G/P)	Good

**Remove & Replace Entire Ramp.**
