Access Compliance Report

Public Rights-of-Way

(Curb Ramps)

Intersection ID: 46784	Main Street: MILLSTREAM RIDGE DR	Cross Street: DOMINION VILLAGE DR	Location: S
ADA ID: 3E37BACF2ED2	Ramp Type: PerpDiag	Initial Pass/Fail: Fail	Overall Compliance: No
Severity Score: 10			
Codes/Mitigation Info/Possible Solution		Field Measurements/Component Compliance

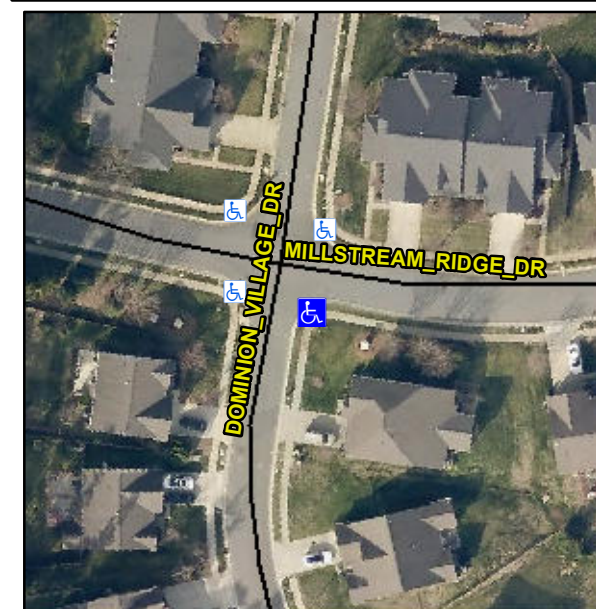
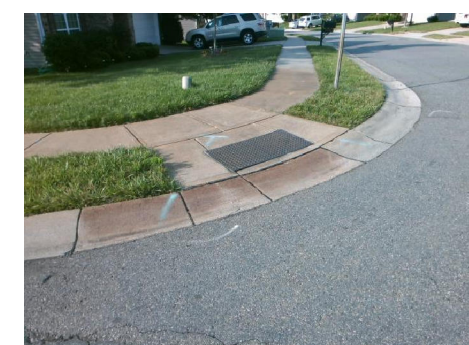
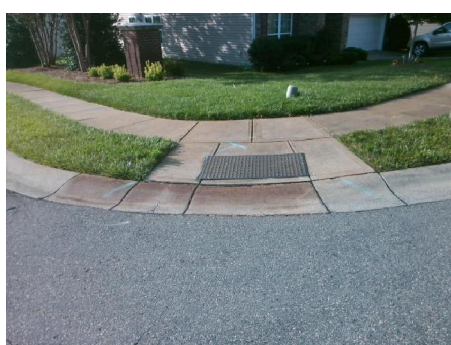
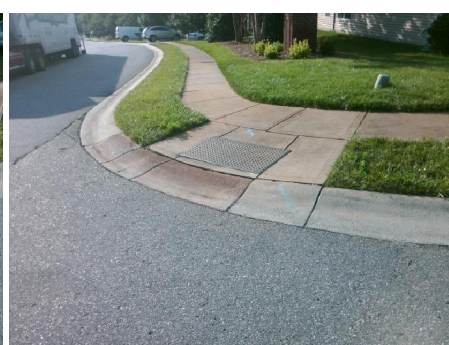
Not Found, R304.5.1, R304.5.3

Compliance	Description	Data	Compliance	Description	Data
N/A	Ramp Length (in)	49.0	Yes	Ramp Slope (%)	5.3
No	Ramp Width (in)	37.0	No	Ramp XSlope (%)	3.2
N/A	Flare Type LT	N/A	N/A	Flare Type RT	N/A
N/A	Flare Slope LT (%)	N/A	N/A	Flare Slope RT (%)	N/A
N/A	Flare Traversable LT?	N/A	N/A	Flare Traversable RT?	N/A
N/A	Landing Length (in)	N/A	N/A	DWS Provided?	N/A
N/A	Landing Width (in)	N/A	N/A	DWS Contrast?	N/A
N/A	Landing Slope (%)	N/A	N/A	DWS Length (in)	N/A
N/A	Landing X Slope (%)	N/A	N/A	DWS Full Width?	N/A
N/A	Landing Curb? (Y/N)	N/A	N/A	DWS Offset (in)	N/A
N/A	Shared Landing?	N/A			
N/A	Gutter Ponding?	N/A	N/A	Gutter Slope (%)	N/A
N/A	Gutter Lip Ht (in)	N/A	N/A	Gutter X Slope (%)	N/A
N/A	Painted X Walk1?	No	N/A	Painted X Walk2?	No
	X Walk 1 Direction	To NE		X Walk 2 Direction	To NW
N/A	X Walk 1 Width (in)	N/A	N/A	X Walk 2 Width (in)	N/A
	X Walk 1 Slope (%)	1.7		X Walk 2 Slope (%)	6.4
	X Walk 1 X Slope (%)	5.1		X Walk 2 X Slope (%)	0.2

N/A	Ramp inside XWalk1?	N/A	N/A	Ramp inside XWalk2?	N/A
	Road Slope (%)	4.1	N/A	Clear Space?	N/A
	Road X Slope (%)	3.5	N/A	Clear Space to XWalk (in)	N/A
N/A	Any Obstructions?	N/A	N/A	Storm Grate/Utility Hazard?	N/A
	Obstruction Type			Storm Grate/Utility Type	
		N/A			N/A
			Yes	Surface Condition? (G/P)	Good

Remove & Replace Curb Ramp With Two New Directional Ramps or Equivalent.
