# Access Compliance Report

## Public Rights-of-Way

### (Curb Ramps)

| Intersection ID: 44472 | Main Street: COREY_COMMON_AV | Cross Street: PRESTBURY_BV | Location: | N |

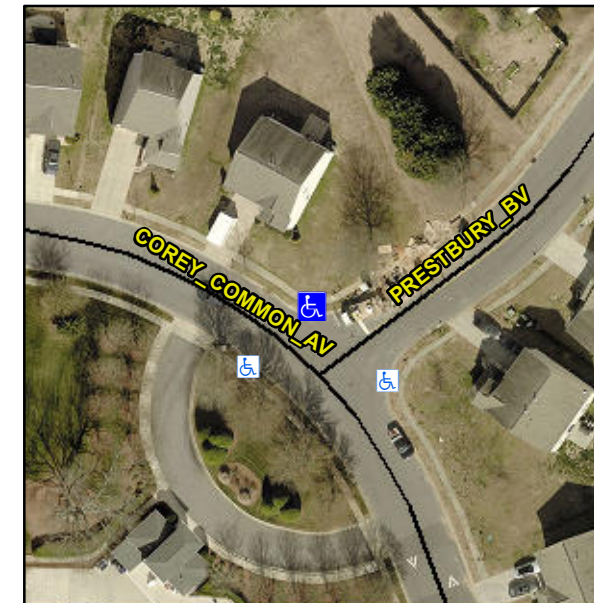
| ADA ID: 3E3935EFA595 | Ramp Type: BlendTrans1 | Initial Pass/Fail: Pass | Overall Compliance: No | Severity Score: 2.5 |

**Not Found, R304.2.1, R305.1.4, R305.2**

| Compliance | Description | Data | Compliance | Description | Data |
|---|---|---|---|---|---|
| No | Landing Length (in) | 47.0 | Yes | DWS Provided? | Yes |
| Yes | Landing X Slope (%) | 0.0 | No | DWS Full Width? | No |
| N/A | Landing Curb? (Y/N) | No | No | DWS Offset (in) | 2.5 |
| | | | No | Curb Slope (%) | 7.3 |

**Remove & Replace Curb Ramp With Two New Directional Ramps or Equivalent.**

Total Cost: \$ 3200.00
