# Access Compliance Report

## Public Rights-of-Way

| Intersection ID: 32220 | Main Street: BRYANT_FARMS_RD | Cross Street: LANCKEN_DR | Location: E |
| ADA ID: 3E55AEE5AC58 | Ramp Type: PerpDiag | Initial Pass/Fail: Fail | Overall Compliance: No |

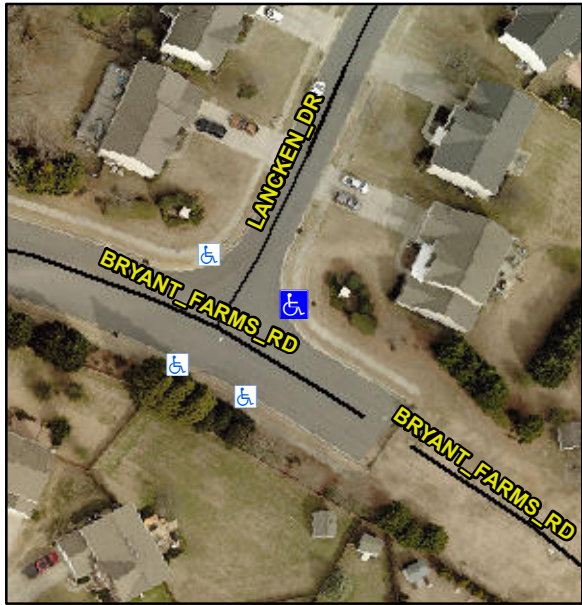
| Severity Score: 21.25 | | | |

R304.5.1, R304.2.2

| Compliance | Description | Data | Compliance | Description | Data |
|---|---|---|---|---|---|
| N/A | Ramp Length (in) | 48.0 | No | Ramp Slope (%) | 9.2 |
| No | Ramp Width (in) | 41.0 | Yes | Ramp XSlope (%) | 1.6 |

Remove & Replace Curb Ramp With Two New Directional Ramps or Equivalent.

3200.00
