Access Compliance Report Public Rights-of-Way (Curb Ramps)

Intersection ID: N/A Main Street: WILKINSON_BV Cross Street: N/A Location: SE

ADA ID: 3E587D6533CC Ramp Type: Directional2 Initial Pass/Fail: Fail Overall Compliance: No Severity Score: 25

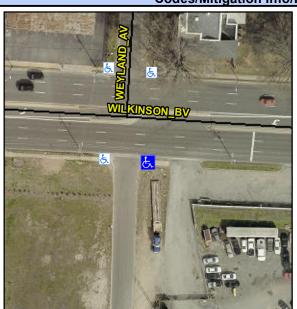
Field Measurements/Component Compliance							
Comp	liance Description	Data	Comp	oliance Description	Data		
N/A	Ramp Length (in)	105.0	N/A	Grade Break?	N/A		
Yes	Ramp Width (in)	64.0	N/A	Grade Break Slope (%)	0.0		
No	Ramp Slope (%)	8.7	N/A	Grade Break XSlope (%)	0.0		
No	Ramp XSlope (%)	5.3					
N/A	Flare Type LT	N/A	N/A	Flare Type RT	N/A		
N/A	Flare Slope LT (%)	N/A	N/A	Flare Slope RT (%)	0.0		
N/A	Flare Traversable LT?	N/A	N/A	Flare Traversable RT?	N/A		
N/A	Landing Length (in)	0.0	N/A	DWS Provided?	N/A		
N/A	Landing Width (in)	0.0	N/A	DWS Contrast?	N/A		
N/A	Landing Slope (%)	0.0	N/A	DWS Length (in)	N/A		
N/A	Landing X Slope (%)	0.0	N/A	DWS Full Width?	N/A		
N/A	Landing Curb? (Y/N)	N/A	N/A	DWS Offset LT (in)	N/A		
N/A	Shared Landing?	N/A	N/A	DWS Offset RT (in)	N/A		
N/A	Gutter Ponding?	0.0	N/A	Gutter Slope (%)	N/A		
N/A	Gutter Lip Ht (in)	0.0	N/A	Gutter X Slope (%)	N/A		
N/A	Painted X Walk1?	No		Road Slope (%)	0.5

X Walk 1 Direction	To SW		Road X Slope (%)	11.2		
	X Walk 1 Width (in)	N/A	l	Clear Space?	N/A		
	X Walk 1 Slope (%)	0.5	N/A	Clear Space to XWalk (in)	N/A		
	X Walk 1 X Slope (%)	11.2	N/A	Storm Grate/Utility Hazard?	N/A		
N/A	Ramp inside XWalk1?	N/A		Storm Grate/Utility Type			
N/A	Any Obstructions?	N/A			N/A		
	Obstruction Type		Yes	Surface Condition? (G/P)	Good		
		N/A	N/A	Curb Slope (%)	1.8

Remove & Replace Entire Ramp. N/A Yes No No No N/A N/A Surveyor Notes: N/A N/A N/A N/A PROW/ADA: R304.2.2, R304.5.3	Possible Solutions:	Com
Yes No No No No N/A Surveyor Notes: N/A N/A N/A N/A PROW/ADA: R304.2.2, R304.5.3 N/A N/A N/A N/A N/A N/A	Remove & Replace Entire Ramp.	N/A
No No N/A N/A Surveyor Notes: N/A N/A N/A N/A N/A PROW/ADA: N/A R304.2.2, R304.5.3 N/A N/A N/A		Yes
N/A N/A Surveyor Notes: N/A N/A N/A N/A N/A N/A PROW/ADA: N/A R304.2.2, R304.5.3 N/A N/A		No
N/A Surveyor Notes: N/A N/A N/A N/A N/A PROW/ADA: N/A R304.2.2, R304.5.3 N/A N/A		No
Surveyor Notes: N/A N/A N/A N/A N/A N/A N/A PROW/ADA: N/A R304.2.2, R304.5.3 N/A N/A		N/A
N/A N/A N/A N/A N/A N/A N/A PROW/ADA: N/A R304.2.2, R304.5.3 N/A N/A		N/A
N/A N/A N/A N/A PROW/ADA: N/A R304.2.2, R304.5.3 N/A N/A	Surveyor Notes:	N/A
N/A N/A N/A PROW/ADA: N/A R304.2.2, R304.5.3 N/A N/A	N/A	N/A
N/A PROW/ADA: N/A R304.2.2, R304.5.3 N/A N/A		N/A
PROW/ADA: N/A R304.2.2, R304.5.3 N/A N/A		N/A

Total Cost:		\$ 1800.00
