Access Compliance Report

Public Rights-of-Way

(Curb Ramps)

Intersection ID: 18478	Main Street: E_INDEPENDENCE_BV	Cross Street: WALLACE RD	Location: NW
ADA ID: 3E69B61B0E2F	Ramp Type: Perp	Initial Pass/Fail: Fail	Overall Compliance: No
Codes/Mitigation Info/Possible Solution			Severity Score: 25
			Field Measurements/Component Compliance

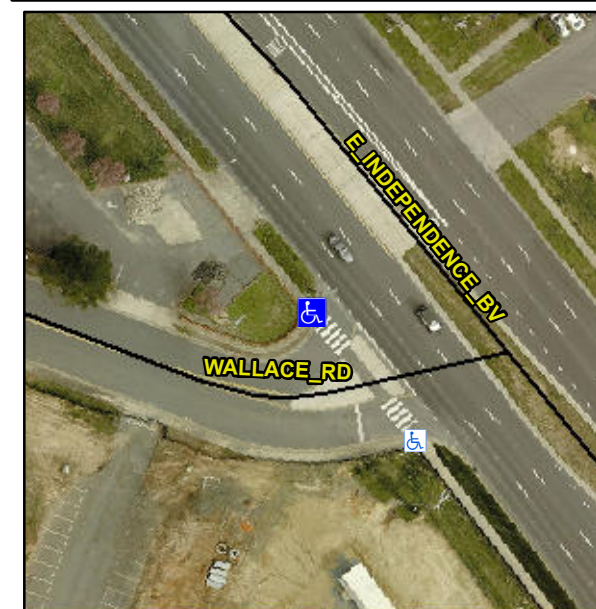
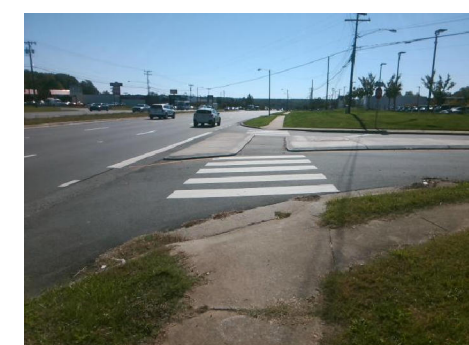
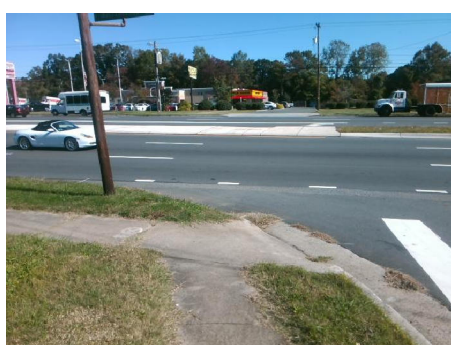
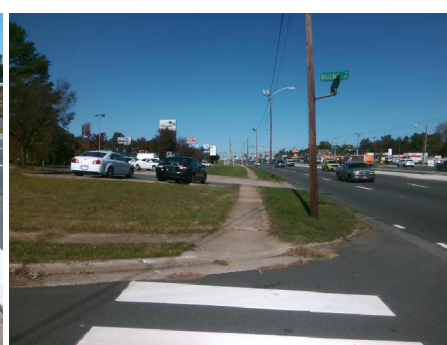
R304.2.2, R304.5.3

Compliance	Description	Data	Compliance	Description	Data
N/A	Ramp Length (in)	67.0	No	Ramp Slope (%)	9.9
Yes	Ramp Width (in)	48.0	No	Ramp XSlope (%)	6.4
N/A	Flare Type LT	N/A	N/A	Flare Type RT	N/A
N/A	Flare Slope LT (%)	N/A	N/A	Flare Slope RT (%)	N/A
N/A	Flare Traversable LT?	N/A	N/A	Flare Traversable RT?	N/A
N/A	Landing Length (in)	N/A	N/A	DWS Provided?	N/A
N/A	Landing Width (in)	N/A	N/A	DWS Contrast?	N/A
N/A	Landing Slope (%)	N/A	N/A	DWS Length (in)	N/A
N/A	Landing X Slope (%)	N/A	N/A	DWS Full Width?	N/A
N/A	Landing Curb? (Y/N)	N/A	N/A	DWS Offset (in)	N/A
N/A	Shared Landing?	N/A			
N/A	Gutter Ponding?	N/A	N/A	Gutter Slope (%)	N/A
N/A	Gutter Lip Ht (in)	N/A	N/A	Gutter X Slope (%)	N/A
N/A	Painted X Walk1?	Yes	N/A	Painted X Walk2?	N/A
	X Walk 1 Direction	To S		X Walk 2 Direction	N/A
N/A	X Walk 1 Width (in)	125.0	N/A	X Walk 2 Width (in)	N/A
	X Walk 1 Slope (%)	0.1		X Walk 2 Slope (%)	N/A
	X Walk 1 X Slope (%)	6.1		X Walk 2 X Slope (%)	N/A

N/A	Ramp inside XWalk1?	Yes	N/A	Ramp inside XWalk2?	N/A
	Road Slope (%)	N/A	N/A	Clear Space?	N/A
	Road X Slope (%)	N/A	N/A	Clear Space to XWalk (in)	N/A
N/A	Any Obstructions?	N/A	N/A	Storm Grate/Utility Hazard?	N/A
	Obstruction Type			Storm Grate/Utility Type	
		N/A			N/A
			Yes	Surface Condition? (G/P)	Good

Possible Solutions:

Remove & Replace Entire Ramp.
