Access Compliance Report

Public Rights-of-Way

(Curb Ramps)

Intersection ID: 47698	Main Street: WATER_OAK_RD	Cross Street: LEES_COURT_ST	Location: NW
ADA ID: 3E6D3FDBF28D	Ramp Type: PerpDiag	Initial Pass/Fail: Fail	Overall Compliance: No
Severity Score: 37.5			
Codes/Mitigation Info/Possible Solution		Field Measurements/Component Compliance

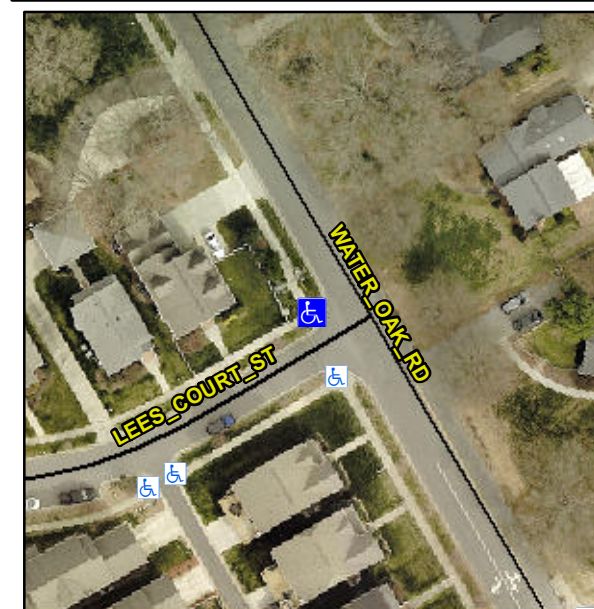
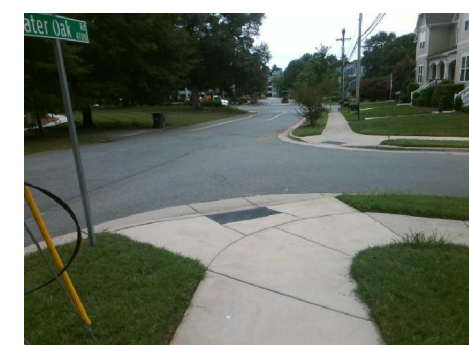
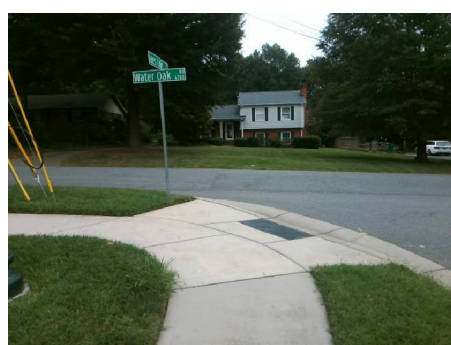
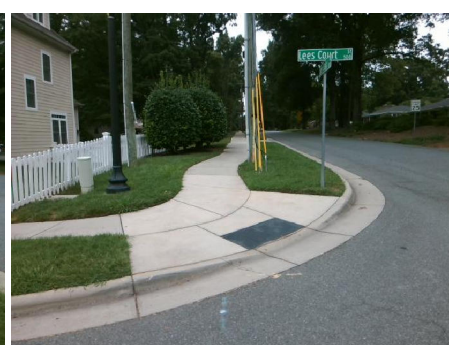
Compliance	Description	Data	Compliance	Description	Data
N/A	Ramp Length (in)	108.0	No	Ramp Slope (%)	9.0
Yes	Ramp Width (in)	48.0	No	Ramp XSlope (%)	9.6
N/A	Flare Type LT	N/A	N/A	Flare Type RT	N/A
N/A	Flare Slope LT (%)	N/A	N/A	Flare Slope RT (%)	N/A
N/A	Flare Traversable LT?	N/A	N/A	Flare Traversable RT?	N/A
N/A	Landing Length (in)	N/A	N/A	DWS Provided?	N/A
N/A	Landing Width (in)	N/A	N/A	DWS Contrast?	N/A
N/A	Landing Slope (%)	N/A	N/A	DWS Length (in)	N/A
N/A	Landing X Slope (%)	N/A	N/A	DWS Full Width?	N/A
N/A	Landing Curb? (Y/N)	N/A	N/A	DWS Offset (in)	N/A
N/A	Shared Landing?	N/A			
N/A	Gutter Ponding?	N/A	N/A	Gutter Slope (%)	N/A
N/A	Gutter Lip Ht (in)	N/A	N/A	Gutter X Slope (%)	N/A
N/A	Painted X Walk1?	No	N/A	Painted X Walk2?	No
	X Walk 1 Direction	To SE		X Walk 2 Direction	To E
N/A	X Walk 1 Width (in)	N/A	N/A	X Walk 2 Width (in)	N/A
	X Walk 1 Slope (%)	3.2		X Walk 2 Slope (%)	4.0
	X Walk 1 X Slope (%)	6.3		X Walk 2 X Slope (%)	4.1

N/A	Ramp inside XWalk1?	N/A	N/A	Ramp inside XWalk2?	N/A
	Road Slope (%)	8.3	N/A	Clear Space?	N/A
	Road X Slope (%)	1.9	N/A	Clear Space to XWalk (in)	N/A
N/A	Any Obstructions?	N/A	N/A	Storm Grate/Utility Hazard?	N/A
	Obstruction Type			Storm Grate/Utility Type	
		N/A			N/A
			Yes	Surface Condition? (G/P)	Good

Remove & Replace Curb Ramp With Two New Directional Ramps or Equivalent.
