# Access Compliance Report

## Public Rights-of-Way

### (Curb Ramps)

Intersection ID: 30377	Main Street: JUSTINS_FOREST_DR	Cross Street: VERNEDALE_GLEN_DR	Location: SW
ADA ID: 3E6EEF650A38	Ramp Type: PerpDiag	Initial Pass/Fail: Fail	Overall Compliance: No
		Severity Score: 10

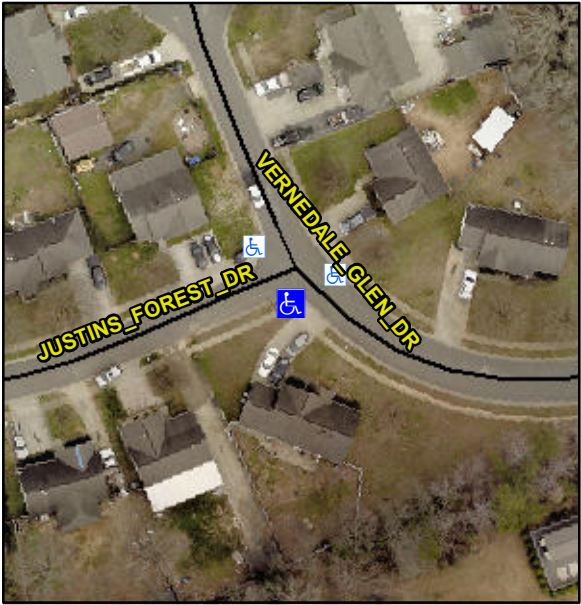
Possible Solutions:		<b>Compliance</b>	<b>Description</b>	<b>Data</b>
	<b>Remove &amp; Replace Curb Ramp With Two New Directional Ramps or Equivalent.</b>		<b>Yes</b>	Ramp Length (in)	6.2
			<b>No</b>	Ramp Width (in)	2.5
			<b>N/A</b>	Flare Type LT	N/A
			<b>N/A</b>	Flare Slope LT (%)	N/A
			<b>N/A</b>	Flare Traversable LT?	N/A
			<b>N/A</b>	Landing Length (in)	N/A
			<b>N/A</b>	Landing Width (in)	N/A
			<b>N/A</b>	Landing Slope (%)	N/A
			<b>N/A</b>	Landing X Slope (%)	N/A
<p>Surveyor Notes:</p> <p><b>N/A</b></p> <p>PROW/ADA:</p> <p><b>R304.5.1, R304.5.3</b></p>			<b>N/A</b>	Flare Type RT	N/A
			<b>N/A</b>	Flare Slope RT (%)	N/A
			<b>N/A</b>	Flare Traversable RT?	N/A
			<b>N/A</b>	DWS Provided?	N/A
			<b>N/A</b>	DWS Contrast?	N/A
			<b>N/A</b>	DWS Length (in)	N/A
			<b>N/A</b>	DWS Full Width?	N/A
			<b>N/A</b>	DWS Offset (in)	N/A

<b>N/A</b>	Shared Landing?	N/A
			<b>N/A</b>	Gutter Ponding?	N/A
			<b>N/A</b>	Gutter Lip Ht (in)	N/A
			<b>No</b>	Painted X Walk1?	No
				X Walk 1 Direction	To E
			<b>N/A</b>	X Walk 1 Width (in)	N/A
			<b>2.2</b>	X Walk 1 Slope (%)	1.8
			<b>1.3</b>	X Walk 1 X Slope (%)	4.0
			<b>N/A</b>	Ramp inside XWalk1?	N/A
			<b>1.4</b>	Road Slope (%)	N/A
			<b>1.7</b>	Road X Slope (%)	N/A
			<b>N/A</b>	Any Obstructions?	N/A
			<b>N/A</b>	Obstruction Type	N/A
			<b>N/A</b>		N/A
			<b>Yes</b>	Surface Condition? (G/P)	Good
