# Access Compliance Report

## Public Rights-of-Way

### (Curb Ramps)

Intersection ID: 14364	Main Street: ALBEMARLE_RD	Cross Street: DWIGHTWARE_BV	Location: SW
ADA ID: 3E7056D2E5B6	Ramp Type: Perp	Initial Pass/Fail: Fail	Overall Compliance: No
		Severity Score: 12.5

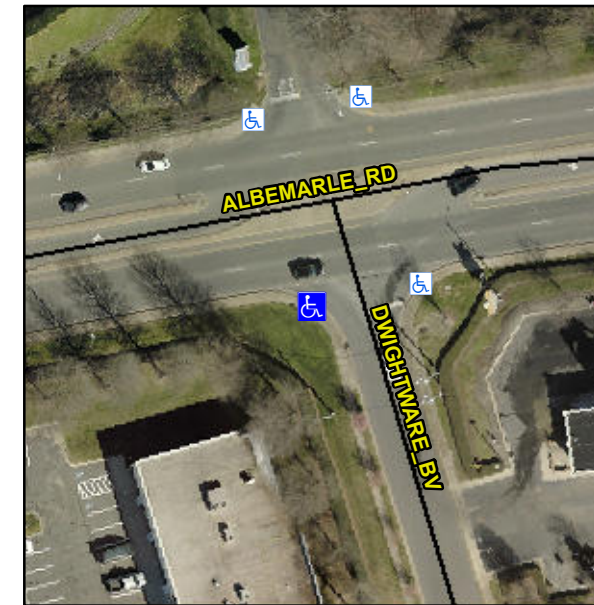
**Not Found, R304.2.2**

Compliance	Description	Data	Compliance	Description	Data
N/A	Ramp Length (in)	60.5	No	Ramp Slope (%)	8.5
Yes	Ramp Width (in)	48.0	Yes	Ramp XSlope (%)	1.8
N/A	Flare Type LT	N/A	N/A	Flare Type RT	N/A
N/A	Flare Slope LT (%)	N/A	N/A	Flare Slope RT (%)	N/A
N/A	Flare Traversable LT?	N/A	N/A	Flare Traversable RT?	N/A
N/A	Landing Length (in)	N/A	N/A	DWS Provided?	N/A
N/A	Landing Width (in)	N/A	N/A	DWS Contrast?	N/A
N/A	Landing Slope (%)	N/A	N/A	DWS Length (in)	N/A
N/A	Landing X Slope (%)	N/A	N/A	DWS Full Width?	N/A
N/A	Landing Curb? (Y/N)	N/A	N/A	DWS Offset (in)	N/A
N/A	Shared Landing?	N/A			
N/A	Gutter Ponding?	N/A	N/A	Gutter Slope (%)	N/A
N/A	Gutter Lip Ht (in)	N/A	N/A	Gutter X Slope (%)	N/A
N/A	Painted X Walk1?	No	N/A	Painted X Walk2?	N/A
	X Walk 1 Direction	To E		X Walk 2 Direction	N/A
N/A	X Walk 1 Width (in)	N/A	N/A	X Walk 2 Width (in)	N/A
	X Walk 1 Slope (%)	0.1		X Walk 2 Slope (%)	N/A
	X Walk 1 X Slope (%)	2.9		X Walk 2 X Slope (%)	N/A

N/A	Ramp inside XWalk1?	N/A	N/A	Ramp inside XWalk2?	N/A
	Road Slope (%)	1.9	N/A	Clear Space?	N/A
	Road X Slope (%)	0.9	N/A	Clear Space to XWalk (in)	N/A
N/A	Any Obstructions?	N/A	N/A	Storm Grate/Utility Hazard?	N/A
	Obstruction Type			Storm Grate/Utility Type	
		N/A			N/A
			Yes	Surface Condition? (G/P)	Good

**Remove & Replace Entire Ramp.**
