Access Compliance Report

Public Rights-of-Way

(Curb Ramps)

Intersection ID: 10028048	Main Street: HARTFORD_AV	Cross Street: N/A	Location: NE
ADA ID: 3E70A3A11071	Ramp Type: ParaDiag	Initial Pass/Fail: Fail	Overall Compliance: No
			Severity Score: 26.25

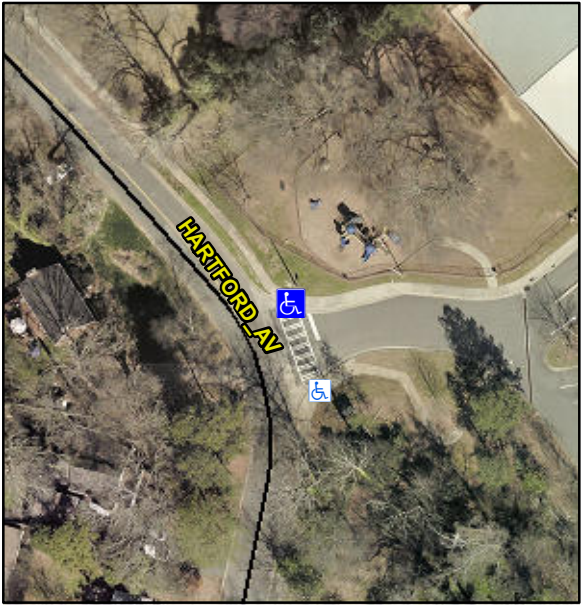
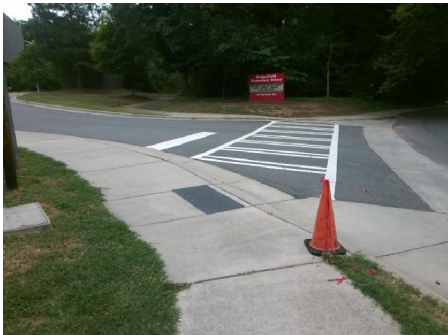
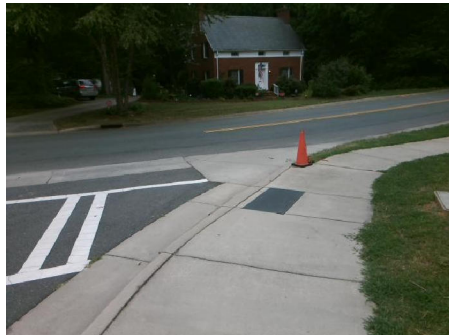
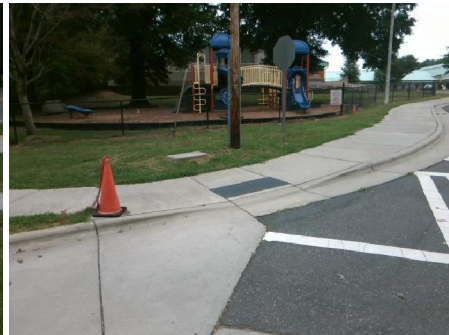
Compliance	Description	Data	Compliance	Description	Data
N/A	Ramp Length LT (in)	60.0	N/A	Ramp Length RT (in)	63.0
Yes	Ramp Width LT (in)	60.0	Yes	Ramp Width RT (in)	72.0
Yes	Ramp Slope LT (%)	1.6	No	Ramp Slope RT (%)	12.3
No	Ramp XSlope LT (%)	2.6	Yes	Ramp XSlope RT (%)	1.7
N/A	Landing Length (in)	N/A	N/A	DWS Provided?	N/A
N/A	Landing Width (in)	N/A	N/A	DWS Contrast?	N/A
N/A	Landing Slope (%)	N/A	N/A	DWS Length (in)	N/A
N/A	Landing X Slope (%)	N/A	N/A	DWS Full Width?	N/A
N/A	Landing Curb? (Y/N)	N/A	N/A	DWS Offset (in)	N/A
N/A	Shared Landing?	N/A			
N/A	Gutter Ponding?	N/A	N/A	Gutter Slope (%)	N/A
N/A	Gutter Lip Ht (in)	N/A	N/A	Gutter X Slope (%)	N/A
N/A	Painted X Walk1?	No	N/A	Painted X Walk2?	Yes
	X Walk 1 Direction	To W		X Walk 2 Direction	To S
N/A	X Walk 1 Width (in)	N/A	N/A	X Walk 2 Width (in)	112.0
	X Walk 1 Slope (%)	8.0		X Walk 2 Slope (%)	0.0
	X Walk 1 X Slope (%)	0.6		X Walk 2 X Slope (%)	8.8
N/A	Ramp inside XWalk1?	N/A	N/A	Ramp inside XWalk2?	Yes

Road Slope (%)	5.5	N/A	Clear Space?	N/A
	Road X Slope (%)	5.6	N/A	Clear Space to XWalk (in)	N/A
N/A	Any Obstructions?	N/A	N/A	Storm Grate/Utility Hazard?	N/A
	Obstruction Type			Storm Grate/Utility Type	
		N/A			N/A
			Yes	Surface Condition? (G/P)	Good
			N/A	Curb Slope (%)	7.6

Possible Solutions:						
	Remove & Replace Curb Ramp With Two New Directional Ramps or Equivalent.						
	Surveyor Notes:						
	LT RP < 5%						
	PROW/ADA:						
	R304.5.3, R304.3.2						
Street 1 Name	HARTFORD AV						
Stop Condition-Street 1	None						
Street 2 Name	ENTRANCE						
Stop Condition-Street 2	StopSign						
Total Cost:		\$	3200.00
