Access Compliance Report

Public Rights-of-Way

(Curb Ramps)

Intersection ID: 11739	Main Street: W_9TH_ST	Cross Street: N_CHURCH_ST	Location: S
ADA ID: 3E7ECD48AA33	Ramp Type: PerpDiag	Initial Pass/Fail: Fail	Overall Compliance: No
			Severity Score: 13.75

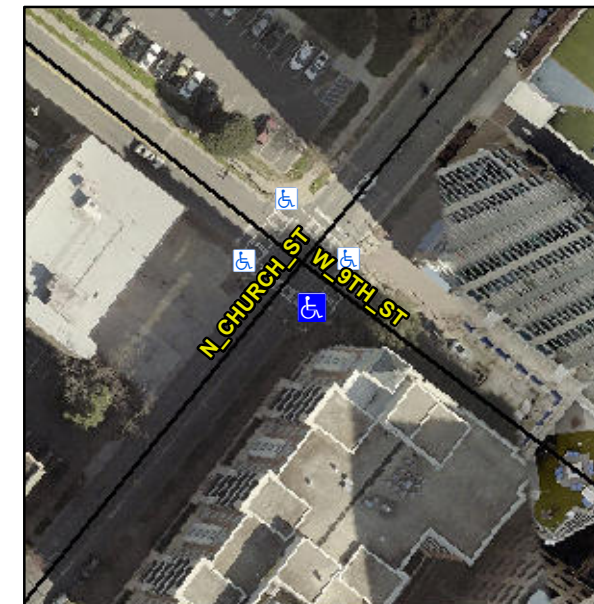
Compliance	Description	Data	Compliance	Description	Data
N/A	Ramp Length (in)	50.0	No	Ramp Slope (%)	8.9
Yes	Ramp Width (in)	53.0	No	Ramp XSlope (%)	4.1
N/A	Flare Type LT	N/A	N/A	Flare Type RT	N/A
N/A	Flare Slope LT (%)	N/A	N/A	Flare Slope RT (%)	N/A
N/A	Flare Traversable LT?	N/A	N/A	Flare Traversable RT?	N/A
N/A	Landing Length (in)	N/A	N/A	DWS Provided?	N/A
N/A	Landing Width (in)	N/A	N/A	DWS Contrast?	N/A
N/A	Landing Slope (%)	N/A	N/A	DWS Length (in)	N/A
N/A	Landing X Slope (%)	N/A	N/A	DWS Full Width?	N/A
N/A	Landing Curb? (Y/N)	N/A	N/A	DWS Offset (in)	N/A
N/A	Shared Landing?	N/A			
N/A	Gutter Ponding?	N/A	N/A	Gutter Slope (%)	N/A
N/A	Gutter Lip Ht (in)	N/A	N/A	Gutter X Slope (%)	N/A
N/A	Painted X Walk1?	Yes	N/A	Painted X Walk2?	Yes
	X Walk 1 Direction	To NE		X Walk 2 Direction	To NW
N/A	X Walk 1 Width (in)	110.0	N/A	X Walk 2 Width (in)	58.0
	X Walk 1 Slope (%)	2.4		X Walk 2 Slope (%)	4.5
	X Walk 1 X Slope (%)	0.3		X Walk 2 X Slope (%)	0.3

N/A	Ramp inside XWalk1?	Yes	N/A	Ramp inside XWalk2?	Yes
	Road Slope (%)	1.3	N/A	Clear Space?	N/A
	Road X Slope (%)	7.0	N/A	Clear Space to XWalk (in)	N/A
N/A	Any Obstructions?	N/A	N/A	Storm Grate/Utility Hazard?	N/A
	Obstruction Type			Storm Grate/Utility Type	
		N/A			N/A
		Yes		Surface Condition? (G/P)	Good

Remove & Replace Curb Ramp With Two New Directional Ramps or Equivalent.

R304.2.2, R304.5.3
