Access Compliance Report Public Rights-of-Way (Curb Ramps)

Intersection ID: 4999 Main Street: E_MALLARD_CREEK_CHURCHCROS Street: STONE_QUARRY_RD Location: W

ADA ID: 3E83A3D0A999 Ramp Type: Perp Initial Pass/Fail: Fail Overall Compliance: No Severity Score: 22.5

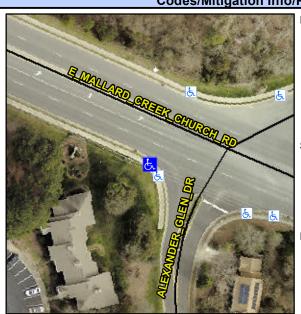
Field Measurements/Component Compliance							
Com	oliance Description	Data	Comp	liance Description	Data		
N/A	Ramp Length (in)	69.0	No	Ramp Slope (%)	10.1		
No	Ramp Width (in)	47.0	Yes	Ramp XSlope (%)	2.2		
N/A	Flare Type LT	N/A	N/A	Flare Type RT	N/A		
N/A	Flare Slope LT (%)	N/A	N/A	Flare Slope RT (%)	N/A		
N/A	Flare Traversable LT?	N/A	N/A	Flare Traversable RT?	N/A		
N/A	Landing Length (in)	N/A	N/A	DWS Provided?	N/A		
N/A	Landing Width (in)	N/A	N/A	DWS Contrast?	N/A		
N/A	Landing Slope (%)	N/A	N/A	DWS Length (in)	N/A		
N/A	Landing X Slope (%)	N/A	N/A	DWS Full Width?	N/A		
N/A	Landing Curb? (Y/N)	N/A	N/A	DWS Offset (in)	N/A		
N/A	Shared Landing?	N/A					
N/A	Gutter Ponding?	N/A	N/A	Gutter Slope (%)	N/A		
N/A	Gutter Lip Ht (in)	N/A	N/A	Gutter X Slope (%)	N/A		
N/A	Painted X Walk1?	No	N/A	Painted X Walk2?	N/A		
	X Walk 1 Direction	To NE		X Walk 2 Direction	N/A		
N/A	X Walk 1 Width (in)	N/A	N/A	X Walk 2 Width (in)	N/A

X Walk 1 Slope (%)	4.1		X Walk 2 Slope (%)	N/A		
	X Walk 1 X Slope (%)	7.6		X Walk 2 X Slope (%)	N/A		
N/A	Ramp inside XWalk1?	N/A	N/A	Ramp inside XWalk2?	N/A		
	Road Slope (%)	N/A	N/A	Clear Space?	N/A		
	Road X Slope (%)	N/A	N/A	Clear Space to XWalk (in)	N/A		
N/A	Any Obstructions?	N/A	N/A	Storm Grate/Utility Hazard?	N/A		
	Obstruction Type			Storm Grate/Utility Type			
		N/A			N/A		
			Yes	Surface Condition? (G/P)	Good		
A LAND

Possible Solutions:	c	
Remove & Replace Entire Ramp.		
·	N	
	N	
	N.	
	N	
	N	
Surveyor Notes:	N	
N/A	N	
	N	
	N	
	N	
PROW/ADA:	N	
R304.5.1, R304.2.2	N.	
	N	
	N	
	N

Total Cost:	\$ 1850.00
