Access Compliance Report

Public Rights-of-Way

(Curb Ramps)

Intersection ID: 31567	Main Street: MCCORD_ST	Cross Street: PEARL_CRESCENT_DR	Location: W
ADA ID: 3E974B8A0DF0	Ramp Type: Perp	Initial Pass/Fail: Pass	Overall Compliance: No
Severity Score: 0			
Codes/Mitigation Info/Possible Solution		Field Measurements/Component Compliance

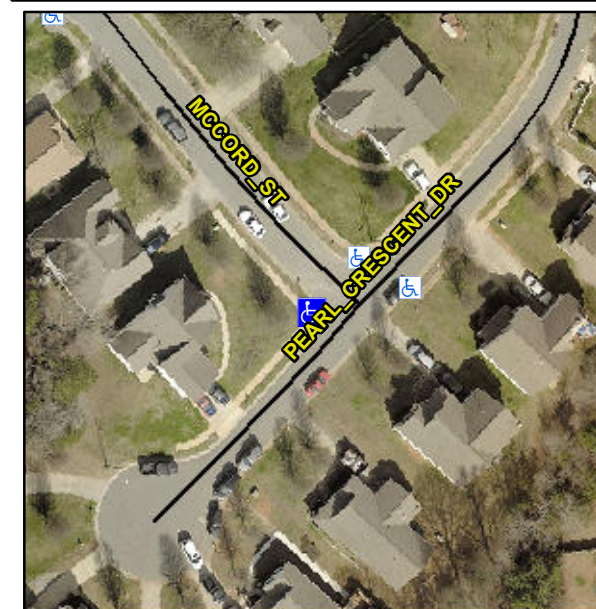
Not Found, R304.2.1, R302.7

Compliance	Description	Data	Compliance	Description	Data
N/A	Ramp Length (in)	46.5	Yes	Ramp Slope (%)	5.3
Yes	Ramp Width (in)	48.0	Yes	Ramp XSlope (%)	1.6
N/A	Flare Type LT	Sloped	N/A	Flare Type RT	N/A
N/A	Flare Slope LT (%)	2.2	Yes	Flare Slope RT (%)	0.8
N/A	Flare Traversable LT?	Yes	N/A	Flare Traversable RT?	Yes
No	Landing Length (in)	47.0	Yes	DWS Provided?	Yes
Yes	Landing Width (in)	48.0	Yes	DWS Contrast?	Yes
Yes	Landing Slope (%)	0.9	Yes	DWS Length (in)	24.5
Yes	Landing X Slope (%)	1.4	Yes	DWS Full Width?	Yes
N/A	Landing Curb? (Y/N)	No	Yes	DWS Offset (in)	0.0
N/A	Shared Landing?	No			
No	Gutter Ponding?	Yes	Yes	Gutter Slope (%)	1.7
Yes	Gutter Lip Ht (in)	0.0	Yes	Gutter X Slope (%)	1.7
N/A	Painted X Walk1?	No	N/A	Painted X Walk2?	N/A
	X Walk 1 Direction	To NE		X Walk 2 Direction	N/A
N/A	X Walk 1 Width (in)	N/A	N/A	X Walk 2 Width (in)	N/A
	X Walk 1 Slope (%)	0.6		X Walk 2 Slope (%)	N/A
	X Walk 1 X Slope (%)	2.7		X Walk 2 X Slope (%)	N/A

N/A	Ramp inside XWalk1?	N/A	N/A	Ramp inside XWalk2?	N/A
	Road Slope (%)	N/A	N/A	Clear Space?	Yes
	Road X Slope (%)	N/A	N/A	Clear Space to XWalk (in)	N/A
Yes	Any Obstructions?	No	Yes	Storm Grate/Utility Hazard?	No
	Obstruction Type			Storm Grate/Utility Type	
		N/A			N/A
			Yes	Surface Condition? (G/P)	Good

Possible Solutions:

Remove & Replace Entire Ramp.
