# Access Compliance Report

## Public Rights-of-Way

### (Curb Ramps)

| Intersection ID: 24227 | Main Street: SHANNOPIN_DR | Cross Street: BEVERLY_CREST_BV | Location: | N |

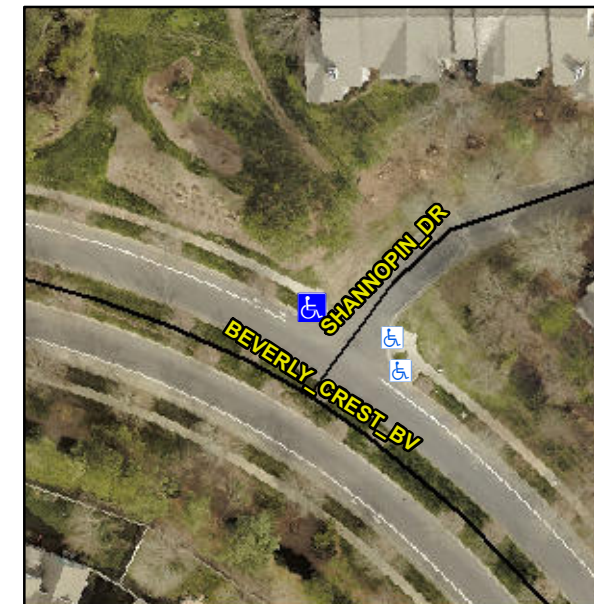
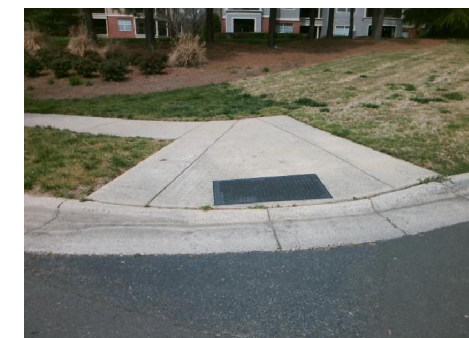
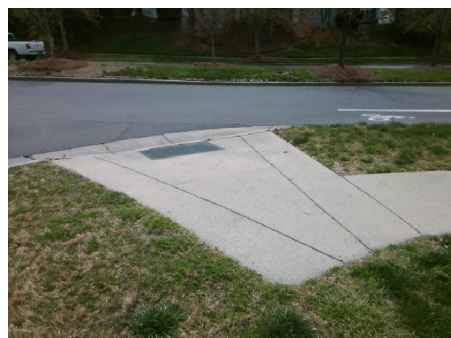
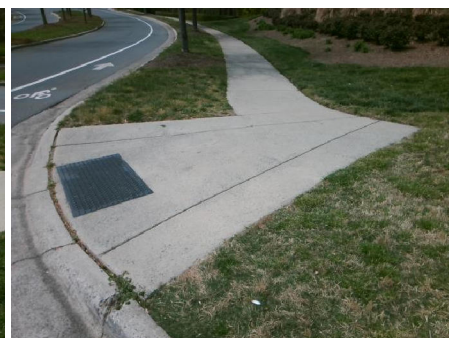
| ADA ID: 3EB82E01E0F7 | Ramp Type: Perp | Initial Pass/Fail: Fail | Overall Compliance: No | Severity Score: 22.5 |

**Not Found, R304.5.1, R304.2.2, R304.5.3**

| Compliance | Description | Data | Compliance | Description | Data |
|---|---|---|---|---|---|
| N/A | Ramp Length (in) | 95.0 | No | Ramp Slope (%) | 8.8 |
| No | Ramp Width (in) | 46.0 | No | Ramp XSlope (%) | 4.9 |

**Remove & Replace Entire Ramp.**
