Access Compliance Report

Public Rights-of-Way

(Curb Ramps)

Intersection ID: 11342	Main Street: GEORGIA_AV	Cross Street: MATHESON_AV	Location: N
ADA ID: 3EB9E86E05F3	Ramp Type: Perp	Initial Pass/Fail: Fail	Overall Compliance: No
Codes/Mitigation Info/Possible Solution		Field Measurements/Component Compliance	
Severity Score: 33.75

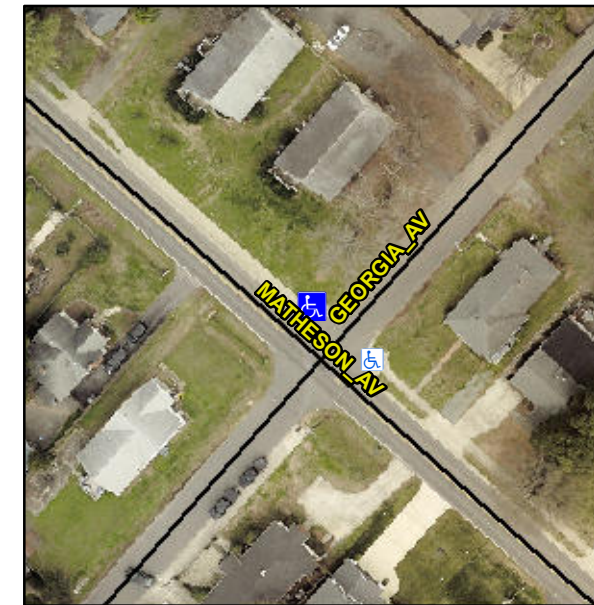
Not Found, R304.5.1, R304.2.2, R304.5.3

Compliance	Description	Data	Compliance	Description	Data
N/A	Ramp Length (in)	73.0	No	Ramp Slope (%)	8.6
No	Ramp Width (in)	41.0	No	Ramp XSlope (%)	6.8
N/A	Flare Type LT	N/A	N/A	Flare Type RT	N/A
N/A	Flare Slope LT (%)	N/A	N/A	Flare Slope RT (%)	N/A
N/A	Flare Traversable LT?	N/A	N/A	Flare Traversable RT?	N/A
N/A	Landing Length (in)	N/A	N/A	DWS Provided?	N/A
N/A	Landing Width (in)	N/A	N/A	DWS Contrast?	N/A
N/A	Landing Slope (%)	N/A	N/A	DWS Length (in)	N/A
N/A	Landing X Slope (%)	N/A	N/A	DWS Full Width?	N/A
N/A	Landing Curb? (Y/N)	N/A	N/A	DWS Offset (in)	N/A
N/A	Shared Landing?	N/A			
N/A	Gutter Ponding?	N/A	N/A	Gutter Slope (%)	N/A
N/A	Gutter Lip Ht (in)	N/A	N/A	Gutter X Slope (%)	N/A
N/A	Painted X Walk1?	No	N/A	Painted X Walk2?	N/A
	X Walk 1 Direction	To SE		X Walk 2 Direction	N/A
N/A	X Walk 1 Width (in)	N/A	N/A	X Walk 2 Width (in)	N/A
	X Walk 1 Slope (%)	2.7		X Walk 2 Slope (%)	N/A
	X Walk 1 X Slope (%)	7.2		X Walk 2 X Slope (%)	N/A

N/A	Ramp inside XWalk1?	N/A	N/A	Ramp inside XWalk2?	N/A
	Road Slope (%)	N/A	N/A	Clear Space?	N/A
	Road X Slope (%)	N/A	N/A	Clear Space to XWalk (in)	N/A
N/A	Any Obstructions?	N/A	N/A	Storm Grate/Utility Hazard?	N/A
	Obstruction Type			Storm Grate/Utility Type	
		N/A			N/A
			Yes	Surface Condition? (G/P)	Good

Possible Solutions:

Remove & Replace Entire Ramp.
