Access Compliance Report

Public Rights-of-Way

(Curb Ramps)

Intersection ID: N/A	Main Street: INDEPENDENCE_RD	Cross Street: N/A	Location: E
ADA ID: 3ECF1CF19273	Ramp Type: Perp	Initial Pass/Fail: Fail	Overall Compliance: No
		Severity Score: 25

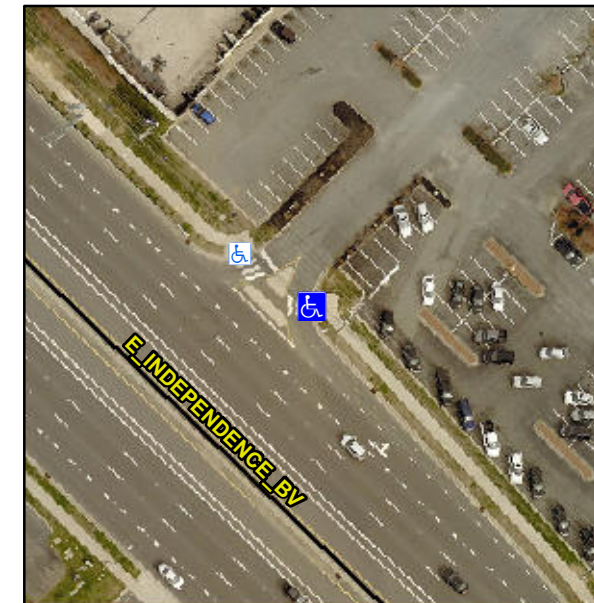
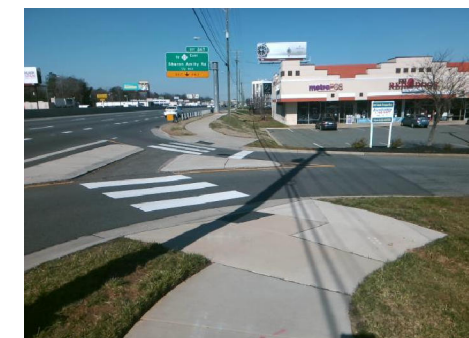
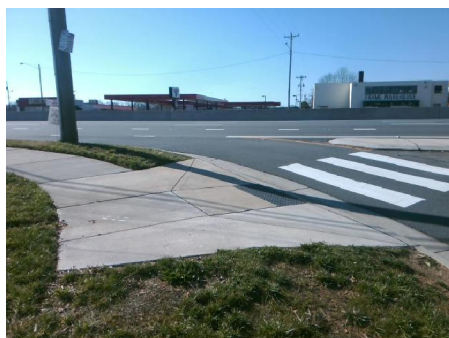
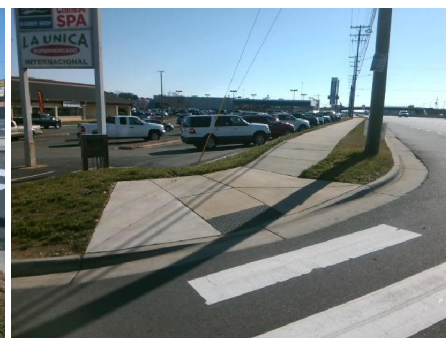
Not Found, R304.5.3

Compliance	Description	Data	Compliance	Description	Data
N/A	Ramp Length (in)	73.0	Yes	Ramp Slope (%)	5.7
Yes	Ramp Width (in)	48.0	No	Ramp XSlope (%)	10.2
N/A	Flare Type LT	N/A	N/A	Flare Type RT	N/A
N/A	Flare Slope LT (%)	N/A	N/A	Flare Slope RT (%)	N/A
N/A	Flare Traversable LT?	N/A	N/A	Flare Traversable RT?	N/A
N/A	Landing Length (in)	N/A	N/A	DWS Provided?	N/A
N/A	Landing Width (in)	N/A	N/A	DWS Contrast?	N/A
N/A	Landing Slope (%)	N/A	N/A	DWS Length (in)	N/A
N/A	Landing X Slope (%)	N/A	N/A	DWS Full Width?	N/A
N/A	Landing Curb? (Y/N)	N/A	N/A	DWS Offset (in)	N/A
N/A	Shared Landing?	N/A			
N/A	Gutter Ponding?	N/A	N/A	Gutter Slope (%)	N/A
N/A	Gutter Lip Ht (in)	N/A	N/A	Gutter X Slope (%)	N/A
N/A	Painted X Walk1?	Yes	N/A	Painted X Walk2?	N/A
	X Walk 1 Direction	To NW		X Walk 2 Direction	N/A
N/A	X Walk 1 Width (in)	119.0	N/A	X Walk 2 Width (in)	N/A
	X Walk 1 Slope (%)	6.8		X Walk 2 Slope (%)	N/A
	X Walk 1 X Slope (%)	9.9		X Walk 2 X Slope (%)	N/A

N/A	Ramp inside XWalk1?	Yes	N/A	Ramp inside XWalk2?	N/A
	Road Slope (%)	N/A	N/A	Clear Space?	N/A
	Road X Slope (%)	N/A	N/A	Clear Space to XWalk (in)	N/A
N/A	Any Obstructions?	N/A	N/A	Storm Grate/Utility Hazard?	N/A
	Obstruction Type			Storm Grate/Utility Type	
		N/A			N/A
		Yes		Surface Condition? (G/P)	Good

Possible Solutions:

Remove & Replace Entire Ramp.

Total Cost: \$ 1850.00
