# Access Compliance Report

## Public Rights-of-Way

### (Curb Ramps)

Intersection ID: 10615	Main Street: SPRATT_ST	Cross Street: POLK_ST	Location: S
ADA ID: 3ED0989C3D69	Ramp Type: Perp	Initial Pass/Fail: Fail	Overall Compliance: No
Severity Score: 10			
Codes/Mitigation Info/Possible Solution		Field Measurements/Component Compliance

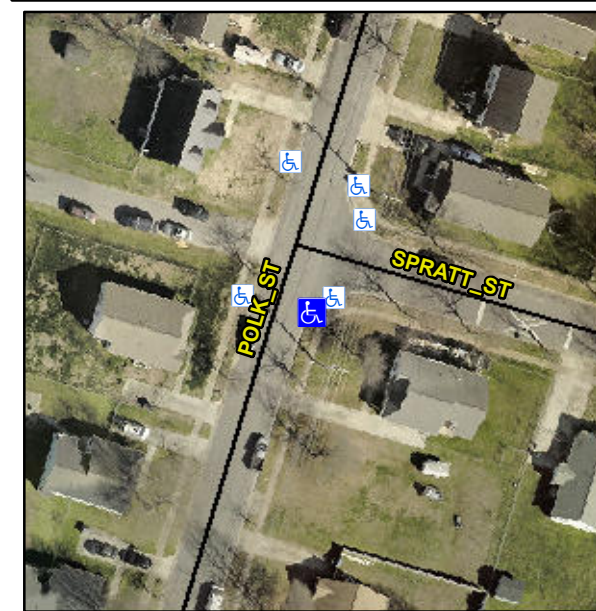
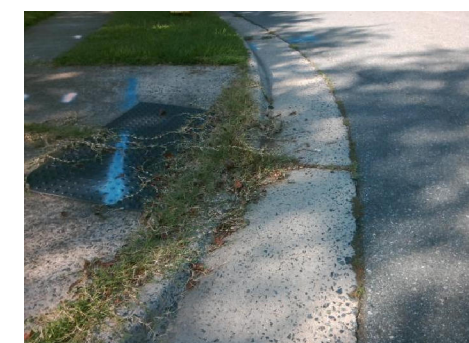
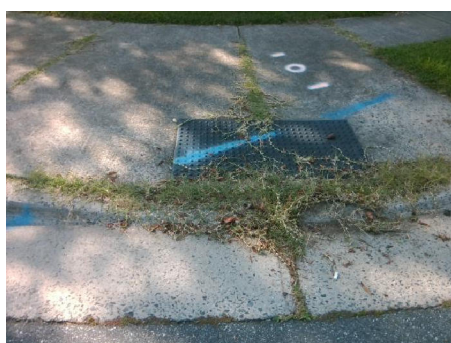
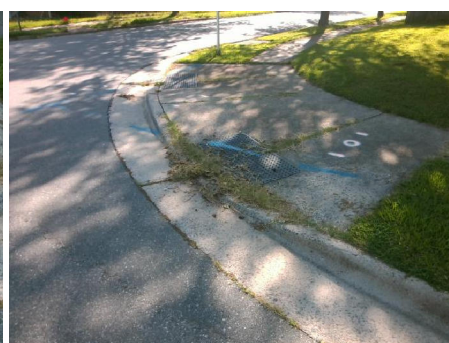
**Not Found, R304.5.1, R304.5.3**

Compliance	Description	Data	Compliance	Description	Data
N/A	Ramp Length (in)	67.0	Yes	Ramp Slope (%)	6.5
No	Ramp Width (in)	47.0	No	Ramp XSlope (%)	2.2
N/A	Flare Type LT	N/A	N/A	Flare Type RT	N/A
N/A	Flare Slope LT (%)	N/A	N/A	Flare Slope RT (%)	N/A
N/A	Flare Traversable LT?	N/A	N/A	Flare Traversable RT?	N/A
N/A	Landing Length (in)	N/A	N/A	DWS Provided?	N/A
N/A	Landing Width (in)	N/A	N/A	DWS Contrast?	N/A
N/A	Landing Slope (%)	N/A	N/A	DWS Length (in)	N/A
N/A	Landing X Slope (%)	N/A	N/A	DWS Full Width?	N/A
N/A	Landing Curb? (Y/N)	N/A	N/A	DWS Offset (in)	N/A
N/A	Shared Landing?	N/A			
N/A	Gutter Ponding?	N/A	N/A	Gutter Slope (%)	N/A
N/A	Gutter Lip Ht (in)	N/A	N/A	Gutter X Slope (%)	N/A
N/A	Painted X Walk1?	No	N/A	Painted X Walk2?	N/A
	X Walk 1 Direction	To NW		X Walk 2 Direction	N/A
N/A	X Walk 1 Width (in)	N/A	N/A	X Walk 2 Width (in)	N/A
	X Walk 1 Slope (%)	5.0		X Walk 2 Slope (%)	N/A
	X Walk 1 X Slope (%)	0.5		X Walk 2 X Slope (%)	N/A

N/A	Ramp inside XWalk1?	N/A	N/A	Ramp inside XWalk2?	N/A
	Road Slope (%)	N/A	N/A	Clear Space?	N/A
	Road X Slope (%)	N/A	N/A	Clear Space to XWalk (in)	N/A
N/A	Any Obstructions?	N/A	N/A	Storm Grate/Utility Hazard?	N/A
	Obstruction Type			Storm Grate/Utility Type	
		N/A			N/A
			Yes	Surface Condition? (G/P)	Good

**Remove & Replace Entire Ramp.**
