# Access Compliance Report

## Public Rights-of-Way

### (Curb Ramps)

| Intersection ID: 18234 | Main Street: PARK_RD | Cross Street: E_WOODLAWN_RD | Location: SE |

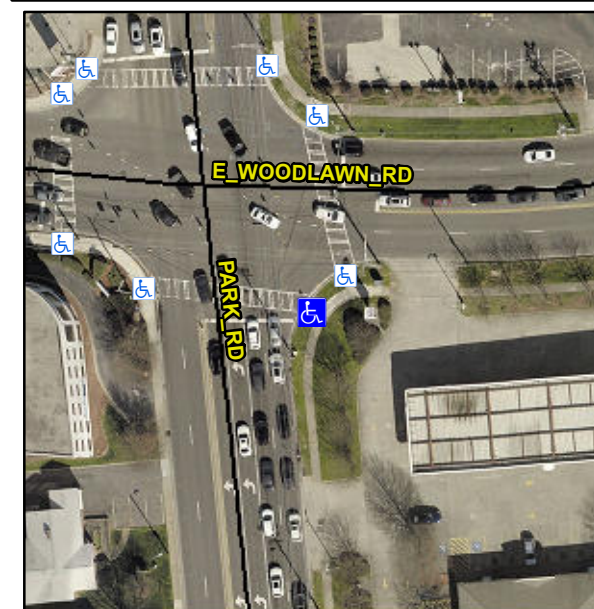
| ADA ID: 3EE3F12BCEA1 | Ramp Type: Directional1 | Initial Pass/Fail: Pass | Overall Compliance: No |

**R304.5.3**

| Compliance | Description | Data | Compliance | Description | Data |
|---|---|---|---|---|---|
| Yes | Ramp Slope (%) | 2.7 | No | Grade Break XSlope (%) | 3.7 |
| Yes | Gutter Lip Ht (in) | 0.0 | No | Gutter X Slope (%) | 3.7 |

**Remove & Replace Entire Ramp.**  
**Remove & Replace Gutter.**
