# Access Compliance Report

## Public Rights-of-Way

### (Curb Ramps)

| Intersection ID: 19960 | Main Street: ARCHDALE_DR | Cross Street: NETHERWOOD_DR | Location: SE |

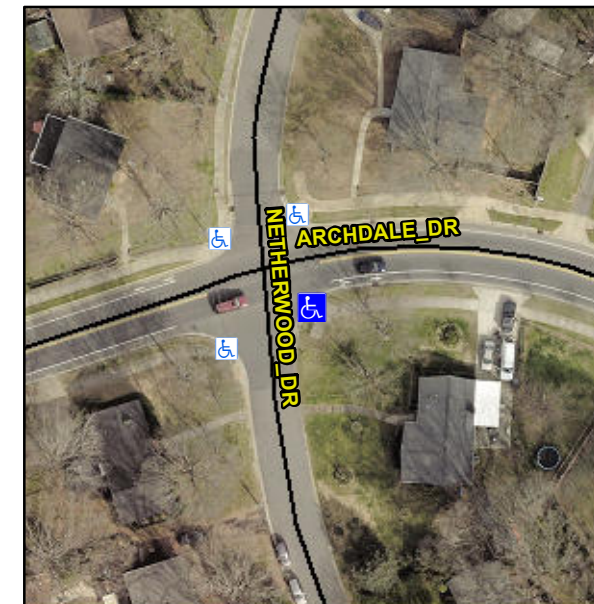
| ADA ID: 3EE53626B07D | Ramp Type: Combination1Diag | Initial Pass/Fail: Fail | Overall Compliance: No |

**Not Found, R304.5.1, R304.5.3, R304.3.2**

| Compliance | Description | Data | Compliance | Description | Data |
|---|---|---|---|---|---|
| No | Ramp Slope LT (%) | 12.1 | No | Ramp Slope RT (%) | 9.0 |
| No | Ramp XSlope LT (%) | 3.1 | Yes | Ramp XSlope RT (%) | 0.8 |
| No | Ramp Width (in) | 46.5 | No | Ramp XSlope (%) | 7.6 |

**Remove & Replace Curb Ramp With Two New Directional Ramps or Equivalent.**

**\$ 3200.00**
