Access Compliance Report

Public Rights-of-Way

(Curb Ramps)

Intersection ID: N/A	Main Street: KELYN_HILLS_DR	Cross Street: KINLEY_COMMONS_LN	Location: E
ADA ID: 3EE8523AB060	Ramp Type: BlendTrans1	Initial Pass/Fail: Fail	Overall Compliance: No
Codes/Mitigation Info/Possible Solution		Field Measurements/Component Compliance	
Severity Score: 10

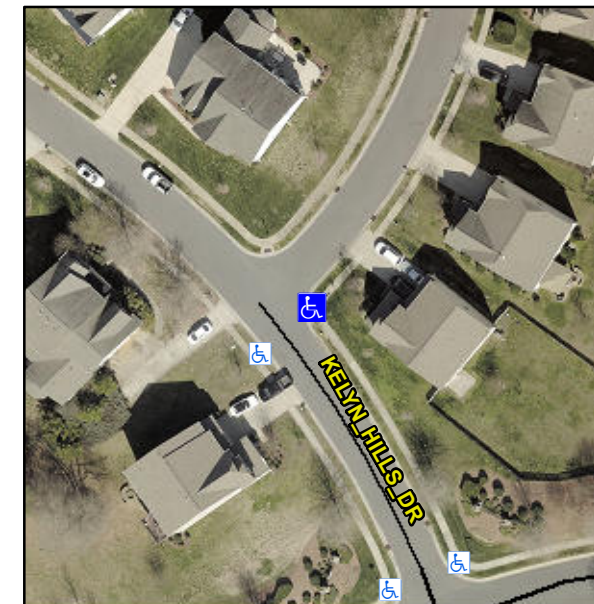
Not Found, R304.5.1, R304.5.3

Compliance	Description	Data	Compliance	Description	Data
N/A	Ramp Length (in)	48.0	Yes	BlendTrans Slope (%)	2.5
No	Ramp Width (in)	44.5	No	BlendTrans XSlope (%)	2.4
N/A	Flare Type LT	N/A	N/A	Flare Type RT	N/A
N/A	Flare Slope LT (%)	N/A	N/A	Flare Slope RT (%)	N/A
N/A	Flare Traversable LT?	N/A	N/A	Flare Traversable RT?	N/A
N/A	Landing Length (in)	N/A	N/A	DWS Provided?	N/A
N/A	Landing Width (in)	N/A	N/A	DWS Contrast?	N/A
N/A	Landing Slope (%)	N/A	N/A	DWS Length (in)	N/A
N/A	Landing X Slope (%)	N/A	N/A	DWS Full Width?	N/A
N/A	Landing Curb? (Y/N)	N/A	N/A	DWS Offset (in)	N/A
N/A	Shared Landing?	N/A			
N/A	Gutter Ponding?	N/A	N/A	Gutter Slope (%)	N/A
N/A	Gutter Lip Ht (in)	N/A	N/A	Gutter X Slope (%)	N/A
N/A	Painted X Walk1?	No	N/A	Painted X Walk2?	No
	X Walk 1 Direction	To NW		X Walk 2 Direction	To SW
	X Walk 1 Width (in)	N/A		X Walk 2 Width (in)	N/A
	X Walk 1 Slope (%)	3.4		X Walk 2 Slope (%)	4.5
	X Walk 1 X Slope (%)	1.8		X Walk 2 X Slope (%)	0.2

N/A	Ramp inside XWalk1?	N/A	N/A	Ramp inside XWalk2?	N/A
	Road Slope (%)	3.6		Clear Space?	N/A
	Road X Slope (%)	4.0	N/A	Clear Space to XWalk (in)	N/A
N/A	Any Obstructions?	N/A	N/A	Storm Grate/Utility Hazard?	N/A
	Obstruction Type			Storm Grate/Utility Type	
		N/A			N/A
			Yes	Surface Condition? (G/P)	Good
			No	Curb Slope (%)	6.2

Remove & Replace Curb Ramp With Two New Directional Ramps or Equivalent.
