Access Compliance Report

Public Rights-of-Way

(Curb Ramps)

Intersection ID: 10637	Main Street: COKER_AV	Cross Street: MATHIS_DR	Location: S
ADA ID: 3EEC2D1B09E8	Ramp Type: BlendTrans2	Initial Pass/Fail: Fail	Overall Compliance: No
		Severity Score: 1.25

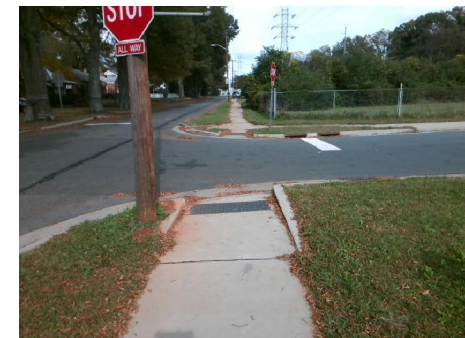
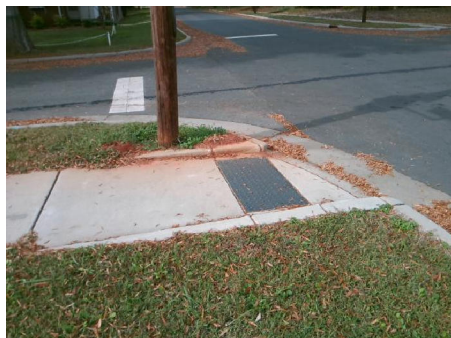
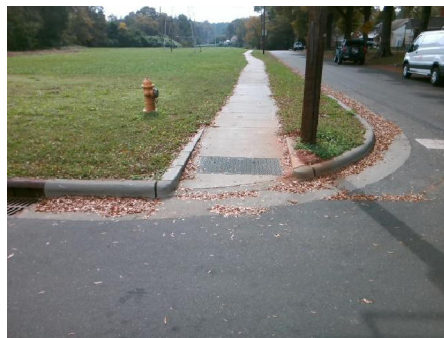
Not Found, R304.5.3

Compliance	Description	Data	Compliance	Description	Data
N/A	Ramp Length (in)	95.0	Yes	BlendTrans Slope (%)	4.6
Yes	Ramp Width (in)	60.0	No	BlendTrans XSlope (%)	3.9
N/A	Flare Type LT	N/A	N/A	Flare Type RT	N/A
N/A	Flare Slope LT (%)	N/A	N/A	Flare Slope RT (%)	N/A
N/A	Flare Traversable LT?	N/A	N/A	Flare Traversable RT?	N/A
N/A	Landing Length (in)	N/A	N/A	DWS Provided?	N/A
N/A	Landing Width (in)	N/A	N/A	DWS Contrast?	N/A
N/A	Landing Slope (%)	N/A	N/A	DWS Length (in)	N/A
N/A	Landing X Slope (%)	N/A	N/A	DWS Full Width?	N/A
N/A	Landing Curb? (Y/N)	N/A	N/A	DWS Offset (in)	N/A
N/A	Shared Landing?	N/A			
N/A	Gutter Ponding?	N/A	N/A	Gutter Slope (%)	N/A
N/A	Gutter Lip Ht (in)	N/A	N/A	Gutter X Slope (%)	N/A
N/A	Painted X Walk1?	No	N/A	Painted X Walk2?	N/A
	X Walk 1 Direction	To NE		X Walk 2 Direction	N/A
	X Walk 1 Width (in)	N/A		X Walk 2 Width (in)	N/A
	X Walk 1 Slope (%)	5.0		X Walk 2 Slope (%)	N/A
	X Walk 1 X Slope (%)	0.1		X Walk 2 X Slope (%)	N/A

N/A	Ramp inside XWalk1?	N/A	N/A	Ramp inside XWalk2?	N/A
	Road Slope (%)	0.1		Clear Space?	N/A
	Road X Slope (%)	5.0	N/A	Clear Space to XWalk (in)	N/A
N/A	Any Obstructions?	N/A	N/A	Storm Grate/Utility Hazard?	N/A
	Obstruction Type			Storm Grate/Utility Type	
		N/A			N/A
			Yes	Surface Condition? (G/P)	Good
			No	Curb Slope (%)	5.2

Remove & Replace Curb Ramp With Two New Directional Ramps or Equivalent.
