Access Compliance Report Public Rights-of-Way (Curb Ramps)

Intersection ID: 16194 Main Street: FERN_GLEN_CT Cross Street: SPLIT OAK DR Location: NE **ADA ID: 3EED38895DDF** Ramp Type: PerpDiag Initial Pass/Fail: Fail **Overall Compliance: No Severity Score:** 50

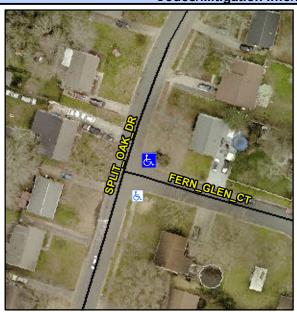
| Field Measurements/Component Compliance | | | | | | |
|---|---|---|---|---|---|---|
| | N/A | Ramp Length (in) | 93.0 | No | Ramp Slope (%) | 14.2 |
| | Yes | Ramp Width (in) | 48.0 | No | Ramp XSlope (%) | 11.0 |

Possible Solutions: Remove & Replace Curb Ramp With **Two New Directional Ramps or** Equivalent. Surveyor Notes: N/A PROW/ADA: Not Found, R304.2.2, R304.5.3
