# Access Compliance Report

## Public Rights-of-Way

Intersection ID: 32087	Main Street: JERPOINT_ABBY_DR	Cross Street: SLADE_CASTLE_CT	Location: SE
ADA ID: 3EF466DE1DA0	Ramp Type: PerpDiag	Initial Pass/Fail: Fail	Overall Compliance: No
		Severity Score: 12.5

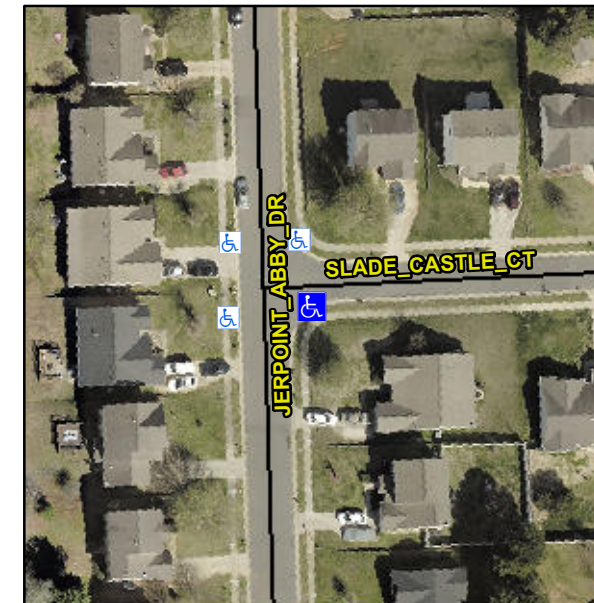
Compliance	Description	Data	Compliance	Description	Data
N/A	Ramp Length (in)	95.0	No	Ramp Slope (%)	10.2
Yes	Ramp Width (in)	80.0	Yes	Ramp XSlope (%)	1.7
N/A	Flare Type LT	N/A	N/A	Flare Type RT	N/A
N/A	Flare Slope LT (%)	N/A	N/A	Flare Slope RT (%)	N/A
N/A	Flare Traversable LT?	N/A	N/A	Flare Traversable RT?	N/A
N/A	Landing Length (in)	N/A	N/A	DWS Provided?	N/A
N/A	Landing Width (in)	N/A	N/A	DWS Contrast?	N/A
N/A	Landing Slope (%)	N/A	N/A	DWS Length (in)	N/A
N/A	Landing X Slope (%)	N/A	N/A	DWS Full Width?	N/A
N/A	Landing Curb? (Y/N)	N/A	N/A	DWS Offset (in)	N/A
N/A	Shared Landing?	N/A			
N/A	Gutter Ponding?	N/A	N/A	Gutter Slope (%)	N/A
N/A	Gutter Lip Ht (in)	N/A	N/A	Gutter X Slope (%)	N/A
N/A	Painted X Walk1?	No	N/A	Painted X Walk2?	No
	X Walk 1 Direction	To N		X Walk 2 Direction	To W
N/A	X Walk 1 Width (in)	N/A	N/A	X Walk 2 Width (in)	N/A
	X Walk 1 Slope (%)	3.4		X Walk 2 Slope (%)	1.7
	X Walk 1 X Slope (%)	2.1		X Walk 2 X Slope (%)	6.9

N/A	Ramp inside XWalk1?	N/A	N/A	Ramp inside XWalk2?	N/A
	Road Slope (%)	0.9	N/A	Clear Space?	N/A
	Road X Slope (%)	4.0	N/A	Clear Space to XWalk (in)	N/A
N/A	Any Obstructions?	N/A	N/A	Storm Grate/Utility Hazard?	N/A
	Obstruction Type			Storm Grate/Utility Type	
		N/A			N/A
			Yes	Surface Condition? (G/P)	Good

**Remove & Replace Curb Ramp With Two New Directional Ramps or Equivalent.**

**R304.2.2**
