Access Compliance Report

Public Rights-of-Way

(Curb Ramps)

Intersection ID: 28322	Main Street: ARDREY_KELL_RD	Cross Street: BEAU_RILEY_RD	Location:	N
ADA ID: 3EF8EFD078C8	Ramp Type: MedianPerp	Initial Pass/Fail: Fail	Overall Compliance: No	Severity Score: 13.75

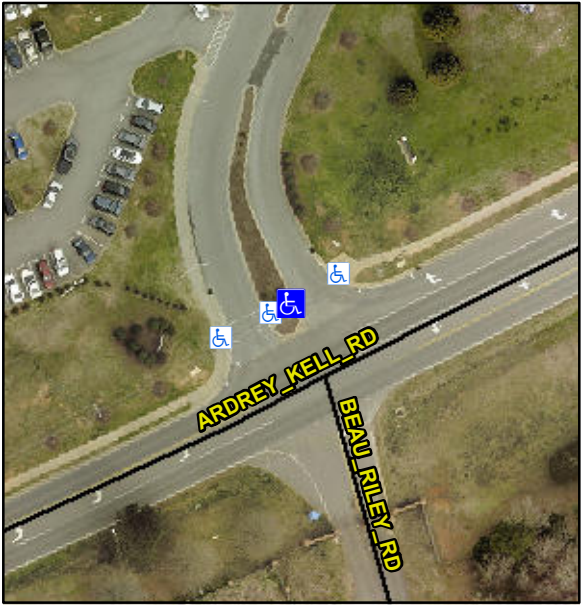
<p>Street 1 Name BEAU RILEY RD</p> <p>Stop Condition-Street 2 None</p> <p>Street 2 Name N/A</p> <p>Stop Condition-Street 1 N/A</p>	Possible Solutions:	Remove & Replace Entire Ramp.			
	Surveyor Notes:	N/A			
	PROW/ADA:	R304.2.2			
	Total Cost:	\$ 1650.00			
			Compliance	Description	Data
			No	Ramp Length (in)	61.0
			Yes	Ramp Width (in)	58.0
			N/A	Flare Type LT	N/A
			N/A	Flare Slope LT (%)	N/A
			N/A	Flare Traversable LT?	N/A
			N/A	Landing Length (in)	N/A
			N/A	Landing Width (in)	N/A
			N/A	Landing Slope (%)	N/A
			N/A	Landing X Slope (%)	N/A
			N/A	Landing Curb? (Y/N)	N/A
			N/A	Shared Landing?	N/A
			N/A	Gutter Ponding?	N/A
			N/A	Gutter Lip Ht (in)	N/A
			N/A	Painted X Walk1?	Yes
			To NE	X Walk 1 Direction	N/A
			N/A	X Walk 1 Width (in)	53.0

2.1	X Walk 1 Slope (%)	N/A
			3.3	X Walk 1 X Slope (%)	N/A
			N/A	Ramp inside XWalk1?	Yes
			N/A	Road Slope (%)	N/A
			N/A	Road X Slope (%)	N/A
			N/A	Any Obstructions?	N/A
			N/A	Obstruction Type	N/A
			N/A	Clear Space?	N/A
			N/A	Clear Space to XWalk (in)	N/A
			N/A	Storm Grate/Utility Hazard?	N/A
			N/A	Storm Grate/Utility Type	N/A
			Yes	Surface Condition? (G/P)	Good
