Access Compliance Report

Public Rights-of-Way

(Curb Ramps)

Intersection ID: 54468	Main Street: COLLINGHAM_DR	Cross Street: STEELE_CREEK_RD	Location: SW
ADA ID: 3F02852DAE6B	Ramp Type: Perp	Initial Pass/Fail: Fail	Overall Compliance: No
Severity Score: 12.5			
Codes/Mitigation Info/Possible Solution		Field Measurements/Component Compliance

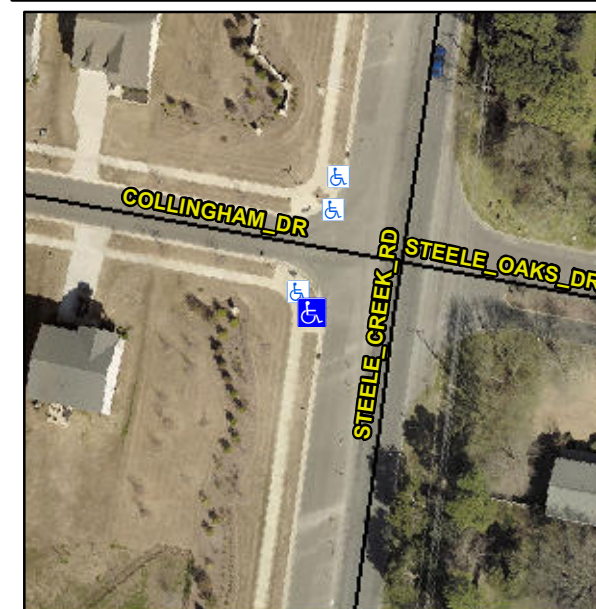
Not Found, R304.2.2

Compliance	Description	Data	Compliance	Description	Data
N/A	Ramp Length (in)	98.0	No	Ramp Slope (%)	9.0
Yes	Ramp Width (in)	57.0	Yes	Ramp XSlope (%)	1.6
N/A	Flare Type LT	N/A	N/A	Flare Type RT	N/A
N/A	Flare Slope LT (%)	N/A	N/A	Flare Slope RT (%)	N/A
N/A	Flare Traversable LT?	N/A	N/A	Flare Traversable RT?	N/A
N/A	Landing Length (in)	N/A	N/A	DWS Provided?	N/A
N/A	Landing Width (in)	N/A	N/A	DWS Contrast?	N/A
N/A	Landing Slope (%)	N/A	N/A	DWS Length (in)	N/A
N/A	Landing X Slope (%)	N/A	N/A	DWS Full Width?	N/A
N/A	Landing Curb? (Y/N)	N/A	N/A	DWS Offset (in)	N/A
N/A	Shared Landing?	N/A			
N/A	Gutter Ponding?	N/A	N/A	Gutter Slope (%)	N/A
N/A	Gutter Lip Ht (in)	N/A	N/A	Gutter X Slope (%)	N/A
N/A	Painted X Walk1?	No	N/A	Painted X Walk2?	N/A
	X Walk 1 Direction	To SE		X Walk 2 Direction	N/A
N/A	X Walk 1 Width (in)	N/A	N/A	X Walk 2 Width (in)	N/A
	X Walk 1 Slope (%)	0.2		X Walk 2 Slope (%)	N/A
	X Walk 1 X Slope (%)	1.3		X Walk 2 X Slope (%)	N/A

Remove & Replace Entire Ramp.

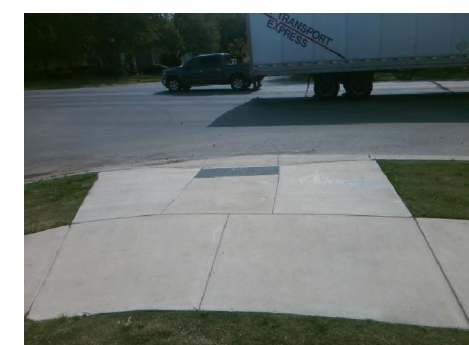
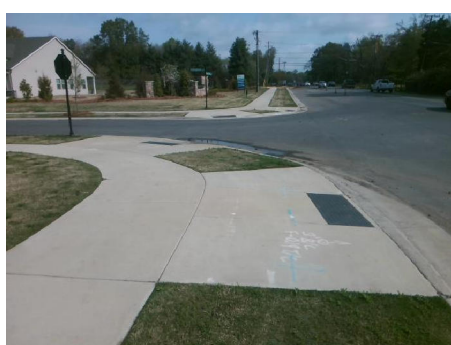
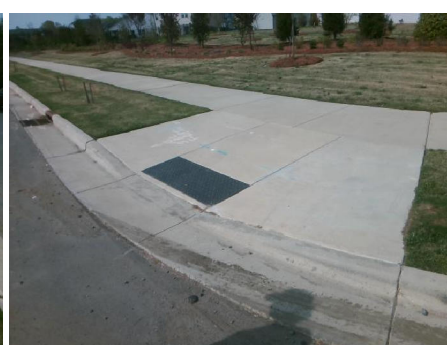
N/A	Ramp inside XWalk1?	N/A	N/A	Ramp inside XWalk2?	N/A
	Road Slope (%)	N/A	N/A	Clear Space?	N/A
	Road X Slope (%)	N/A	N/A	Clear Space to XWalk (in)	N/A
N/A	Any Obstructions?	N/A	N/A	Storm Grate/Utility Hazard?	N/A
	Obstruction Type			Storm Grate/Utility Type	
		N/A			N/A
		Yes		Surface Condition? (G/P)	Good
