# Access Compliance Report

## Public Rights-of-Way

### (Curb Ramps)

Intersection ID: 49801	Main Street: PARSIFAL_LN	Cross Street: GANDOLFO_CT	Location: W
ADA ID: 3F049A3EB72D	Ramp Type: PerpDiag	Initial Pass/Fail: Fail	Overall Compliance: No
Severity Score: 33.75			
Codes/Mitigation Info/Possible Solution		Field Measurements/Component Compliance

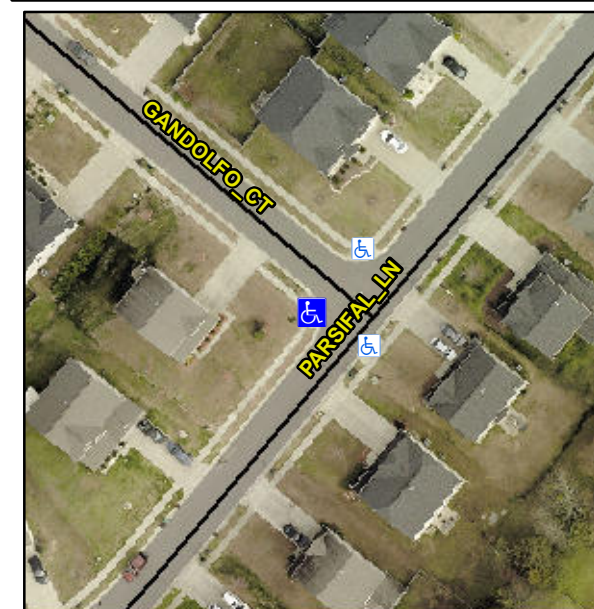
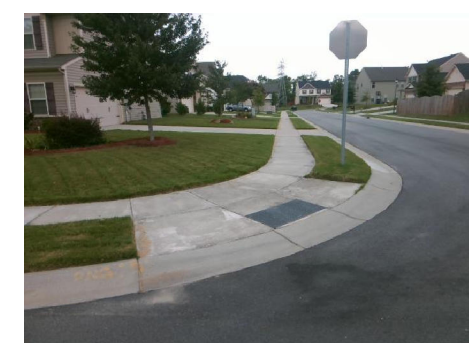
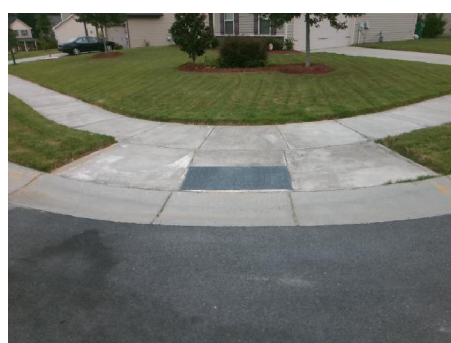
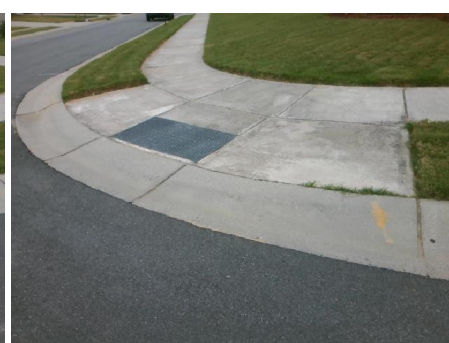
**Not Found, R304.5.1, R304.2.2**

Compliance	Description	Data	Compliance	Description	Data
N/A	Ramp Length (in)	48.0	No	Ramp Slope (%)	17.4
No	Ramp Width (in)	47.0	Yes	Ramp XSlope (%)	0.5
N/A	Flare Type LT	N/A	N/A	Flare Type RT	N/A
N/A	Flare Slope LT (%)	N/A	N/A	Flare Slope RT (%)	N/A
N/A	Flare Traversable LT?	N/A	N/A	Flare Traversable RT?	N/A
N/A	Landing Length (in)	N/A	N/A	DWS Provided?	N/A
N/A	Landing Width (in)	N/A	N/A	DWS Contrast?	N/A
N/A	Landing Slope (%)	N/A	N/A	DWS Length (in)	N/A
N/A	Landing X Slope (%)	N/A	N/A	DWS Full Width?	N/A
N/A	Landing Curb? (Y/N)	N/A	N/A	DWS Offset (in)	N/A
N/A	Shared Landing?	N/A			
N/A	Gutter Ponding?	N/A	N/A	Gutter Slope (%)	N/A
N/A	Gutter Lip Ht (in)	N/A	N/A	Gutter X Slope (%)	N/A
N/A	Painted X Walk1?	No	N/A	Painted X Walk2?	No
	X Walk 1 Direction	To SE		X Walk 2 Direction	To NE
N/A	X Walk 1 Width (in)	N/A	N/A	X Walk 2 Width (in)	N/A
	X Walk 1 Slope (%)	1.8		X Walk 2 Slope (%)	3.9
	X Walk 1 X Slope (%)	2.0		X Walk 2 X Slope (%)	0.4

N/A	Ramp inside XWalk1?	N/A	N/A	Ramp inside XWalk2?	N/A
	Road Slope (%)	0.4	N/A	Clear Space?	N/A
	Road X Slope (%)	1.4	N/A	Clear Space to XWalk (in)	N/A
N/A	Any Obstructions?	N/A	N/A	Storm Grate/Utility Hazard?	N/A
	Obstruction Type			Storm Grate/Utility Type	
		N/A			N/A
			Yes	Surface Condition? (G/P)	Good

**Remove & Replace Curb Ramp With Two New Directional Ramps or Equivalent.**
