Access Compliance Report

Public Rights-of-Way

(Curb Ramps)

Intersection ID: 24621	Main Street: HUGH_FOREST_RD	Cross Street: WALTHAM_LN	Location: NE
ADA ID: 3F06BA1029F5	Ramp Type: BlendTrans1	Initial Pass/Fail: Fail	Overall Compliance: No
Severity Score: 10			
Codes/Mitigation Info/Possible Solution		Field Measurements/Component Compliance

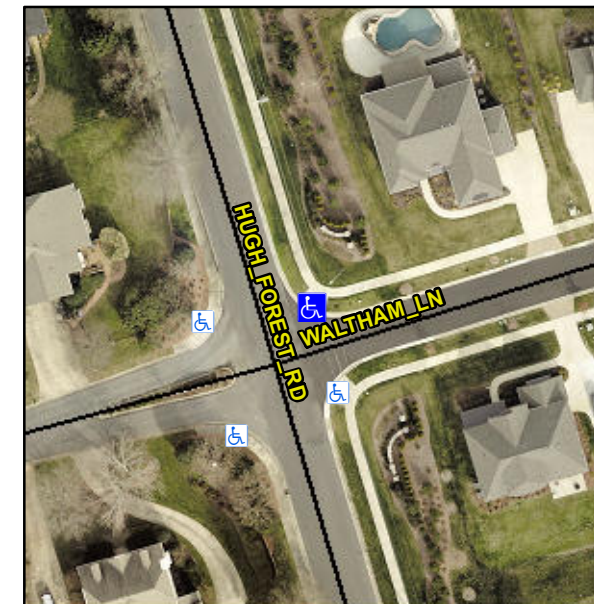
Not Found, R304.5.1, R304.5.3

Compliance	Description	Data	Compliance	Description	Data
N/A	Ramp Length (in)	96.0	Yes	BlendTrans Slope (%)	4.7
No	Ramp Width (in)	39.5	No	BlendTrans XSlope (%)	3.5
N/A	Flare Type LT	N/A	N/A	Flare Type RT	N/A
N/A	Flare Slope LT (%)	N/A	N/A	Flare Slope RT (%)	N/A
N/A	Flare Traversable LT?	N/A	N/A	Flare Traversable RT?	N/A
N/A	Landing Length (in)	N/A	N/A	DWS Provided?	N/A
N/A	Landing Width (in)	N/A	N/A	DWS Contrast?	N/A
N/A	Landing Slope (%)	N/A	N/A	DWS Length (in)	N/A
N/A	Landing X Slope (%)	N/A	N/A	DWS Full Width?	N/A
N/A	Landing Curb? (Y/N)	N/A	N/A	DWS Offset (in)	N/A
N/A	Shared Landing?	N/A			
N/A	Gutter Ponding?	N/A	N/A	Gutter Slope (%)	N/A
N/A	Gutter Lip Ht (in)	N/A	N/A	Gutter X Slope (%)	N/A
N/A	Painted X Walk1?	No	N/A	Painted X Walk2?	No
	X Walk 1 Direction	To W		X Walk 2 Direction	To S
	X Walk 1 Width (in)	N/A		X Walk 2 Width (in)	N/A
	X Walk 1 Slope (%)	2.8		X Walk 2 Slope (%)	2.3
	X Walk 1 X Slope (%)	0.5		X Walk 2 X Slope (%)	3.5

N/A	Ramp inside XWalk1?	N/A	N/A	Ramp inside XWalk2?	N/A
	Road Slope (%)	1.9		Clear Space?	N/A
	Road X Slope (%)	1.0	N/A	Clear Space to XWalk (in)	N/A
N/A	Any Obstructions?	N/A	N/A	Storm Grate/Utility Hazard?	N/A
	Obstruction Type			Storm Grate/Utility Type	
		N/A			N/A
			Yes	Surface Condition? (G/P)	Good
			No	Curb Slope (%)	12.5

Remove & Replace Curb Ramp With Two New Directional Ramps or Equivalent.
