# Access Compliance Report

## Public Rights-of-Way

### (Curb Ramps)

Intersection ID: 45246	Main Street: BEGONIA_DR	Cross Street: KODIAK_CT	Location: SE
ADA ID: 3F0748D3C7C0	Ramp Type: BlendTrans1	Initial Pass/Fail: Pass	Overall Compliance: No
Severity Score: 5.25			
Codes/Mitigation Info/Possible Solution		Field Measurements/Component Compliance

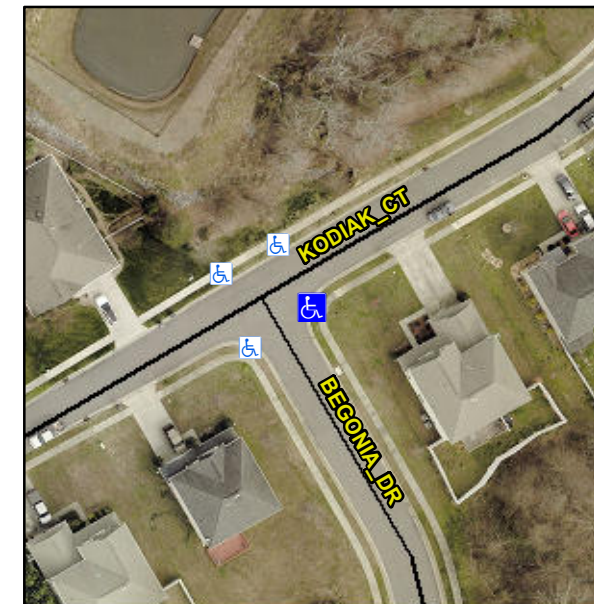
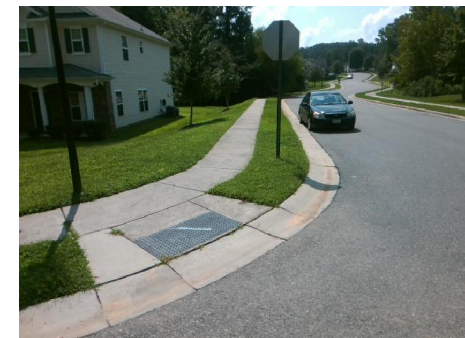
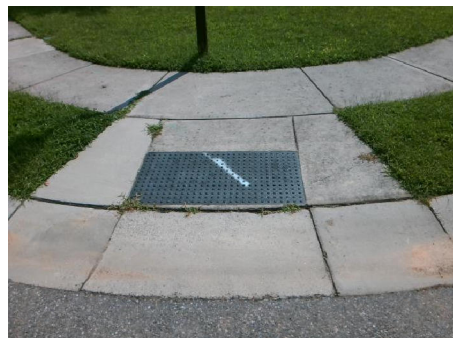
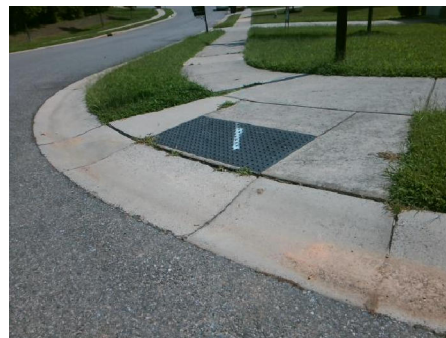
**CURB GAP 1.5**

**Not Found, R304.5.3, R304.2.1, R302.7, R304.5.4**

Compliance	Description	Data	Compliance	Description	Data
N/A	Ramp Length (in)	48.0	Yes	BlendTrans Slope (%)	4.3
Yes	Ramp Width (in)	48.0	No	BlendTrans XSlope (%)	2.8
N/A	Flare Type LT	Sloped	N/A	Flare Type RT	Sloped
N/A	Flare Slope LT (%)	0.7	N/A	Flare Slope RT (%)	3.0
N/A	Flare Traversable LT?	No	N/A	Flare Traversable RT?	No
No	Landing Length (in)	47.5	Yes	DWS Provided?	Yes
Yes	Landing Width (in)	48.0	Yes	DWS Contrast?	Yes
Yes	Landing Slope (%)	0.6	Yes	DWS Length (in)	24.5
No	Landing X Slope (%)	4.4	Yes	DWS Full Width?	Yes
N/A	Landing Curb? (Y/N)	No	Yes	DWS Offset (in)	2.0
N/A	Shared Landing?	No			
No	Gutter Ponding?	Yes	No	Gutter Slope (%)	15.2
Yes	Gutter Lip Ht (in)	0.0	No	Gutter X Slope (%)	3.2
N/A	Painted X Walk1?	No	N/A	Painted X Walk2?	No
	X Walk 1 Direction	To NW		X Walk 2 Direction	To SW
	X Walk 1 Width (in)	N/A		X Walk 2 Width (in)	N/A
	X Walk 1 Slope (%)	3.6		X Walk 2 Slope (%)	3.9
	X Walk 1 X Slope (%)	3.7		X Walk 2 X Slope (%)	1.9

N/A	Ramp inside XWalk1?	N/A	N/A	Ramp inside XWalk2?	N/A
	Road Slope (%)	0.3		Clear Space?	Yes
	Road X Slope (%)	6.1	N/A	Clear Space to XWalk (in)	N/A
Yes	Any Obstructions?	No	Yes	Storm Grate/Utility Hazard?	No
	Obstruction Type			Storm Grate/Utility Type	
		N/A			N/A
			Yes	Surface Condition? (G/P)	Good
			No	Curb Slope (%)	20.9

**Remove & Replace Curb Ramp With Two New Directional Ramps or Equivalent. Remove & Replace Gutter.**
