# Access Compliance Report

## Public Rights-of-Way

### (Curb Ramps)

Intersection ID: 13471	Main Street: FORDHAM_RD	Cross Street: WEST_BV	Location: NW
ADA ID: 3F0C4159BEF3	Ramp Type: ParaDiag	Initial Pass/Fail: Pass	Overall Compliance: No
		Severity Score: 0

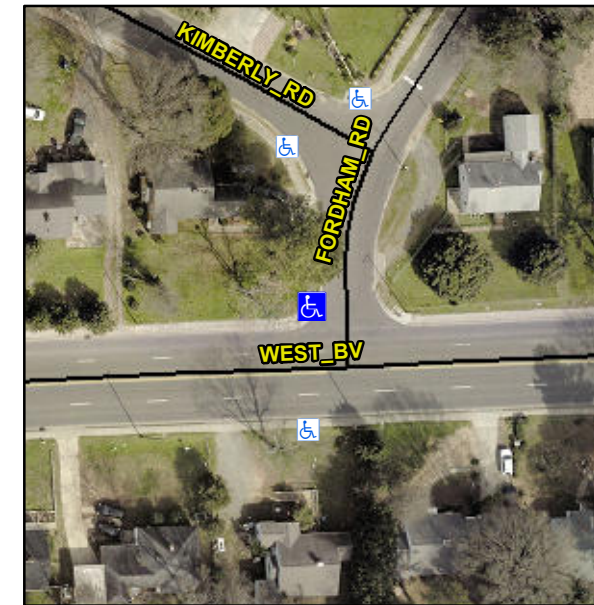
Surveyor Notes:

**RT RP < 5%**

Compliance	Description	Data	Compliance	Description	Data
N/A	Ramp Length LT (in)	53.0	N/A	Ramp Length RT (in)	66.0
Yes	Ramp Width LT (in)	54.5	Yes	Ramp Width RT (in)	59.0
Yes	Ramp Slope LT (%)	6.8	Yes	Ramp Slope RT (%)	2.4
Yes	Ramp XSlope LT (%)	0.7	Yes	Ramp XSlope RT (%)	1.3
Yes	Landing Length (in)	60.0	Yes	DWS Provided?	Yes
Yes	Landing Width (in)	60.0	Yes	DWS Contrast?	Yes
Yes	Landing Slope (%)	0.1	Yes	DWS Length (in)	24.0
Yes	Landing X Slope (%)	0.2	Yes	DWS Full Width?	Yes
N/A	Landing Curb? (Y/N)	No	Yes	DWS Offset (in)	0.0
N/A	Shared Landing?	No			
Yes	Gutter Ponding?	No	Yes	Gutter Slope (%)	0.2
Yes	Gutter Lip Ht (in)	0.0	Yes	Gutter X Slope (%)	1.9
N/A	Painted X Walk1?	No	N/A	Painted X Walk2?	No
	X Walk 1 Direction	To S		X Walk 2 Direction	To E
N/A	X Walk 1 Width (in)	N/A	N/A	X Walk 2 Width (in)	N/A
	X Walk 1 Slope (%)	3.4		X Walk 2 Slope (%)	3.2
	X Walk 1 X Slope (%)	2.6		X Walk 2 X Slope (%)	4.9
N/A	Ramp inside XWalk1?	N/A	N/A	Ramp inside XWalk2?	N/A

Road Slope (%)	1.5	N/A	Clear Space?	Yes
	Road X Slope (%)	0.6	N/A	Clear Space to XWalk (in)	N/A
Yes	Any Obstructions?	No	Yes	Storm Grate/Utility Hazard?	No
	Obstruction Type			Storm Grate/Utility Type	
		N/A			N/A
			Yes	Surface Condition? (G/P)	Good
			Replace	Curb Slope (%)	9.5

Possible Solutions:

**Remove & Replace Curb Slope and Extend Ramp.**
